## CASE STUDY

Thames Water, Mogden STW

OCU REFURBISHMENTS 2021

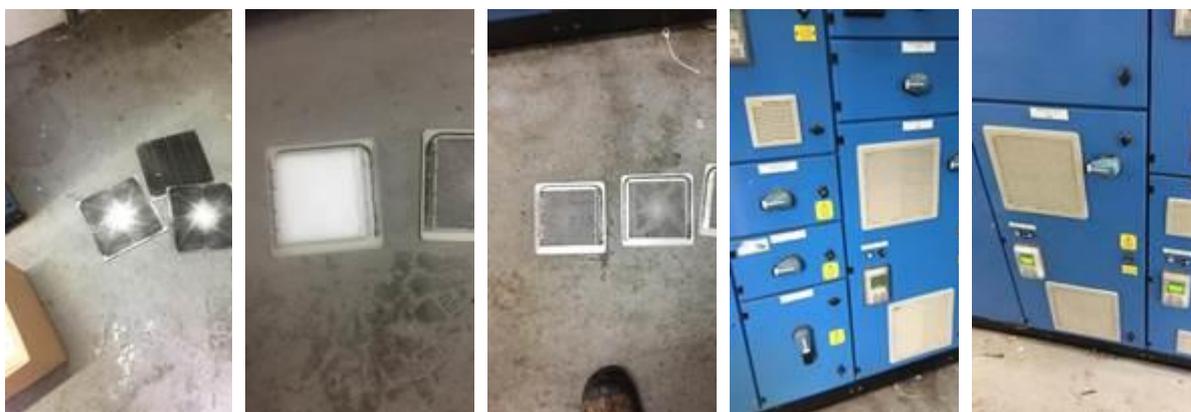
#### Replace inverter fan panel mesh

Fan and vent filter mats swapped for 2-off fans and 4-off dosing pump MCC inverter cubicles including washing the outer finger guard grills. Please see below before and after photos:

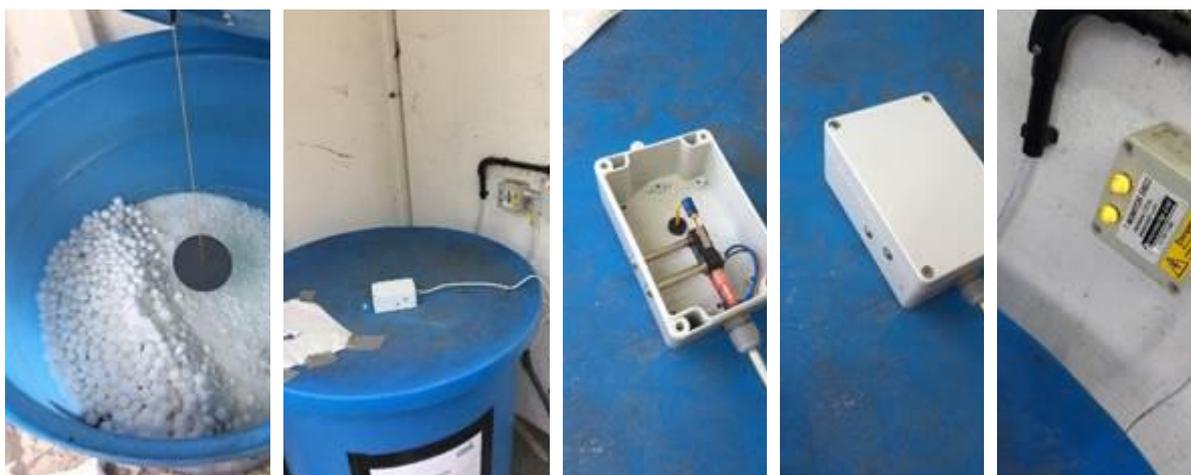
#### Repairs to water softener, new Salt Level Switch

New level switch assembly fitted and connected to existing local level switch control unit. Low salt alarm level set at approximately 600mm below brine tank lid. Tested new switch, correctly generates alarm on local control unit and on OUC12 HMI.

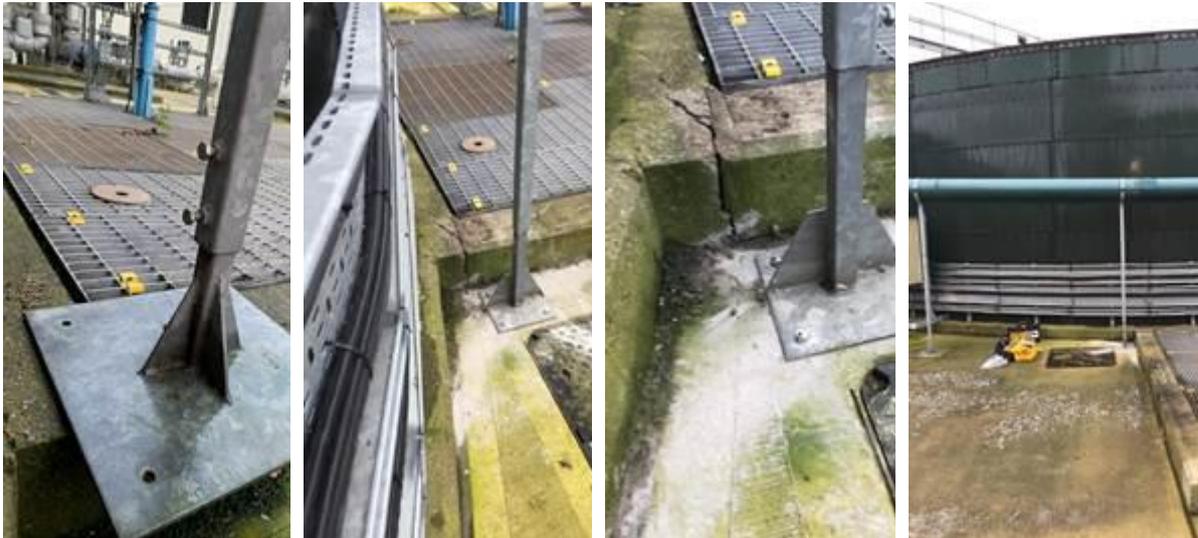
### Reposition existing support

Existing support post baseplate was too large to be fixed down in the area the original manufacturers had attempted to position, we therefore changed the baseplate for a new smaller version to suit the ductwork line. Please see below before & after photos.

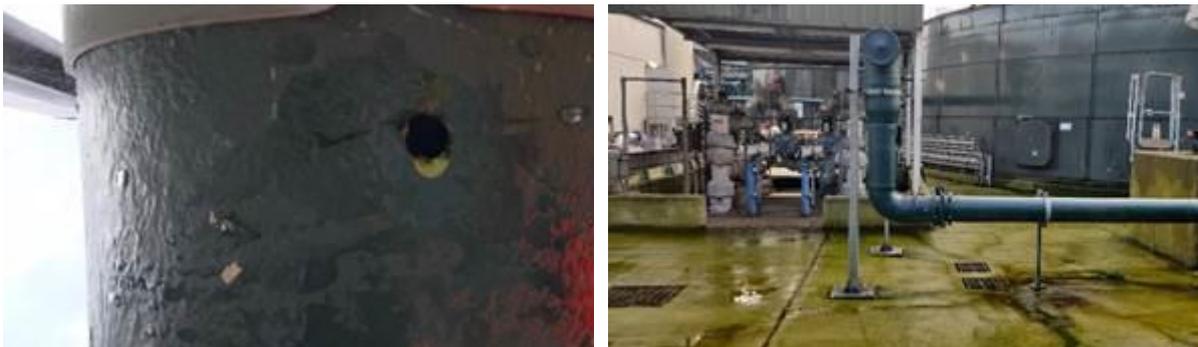
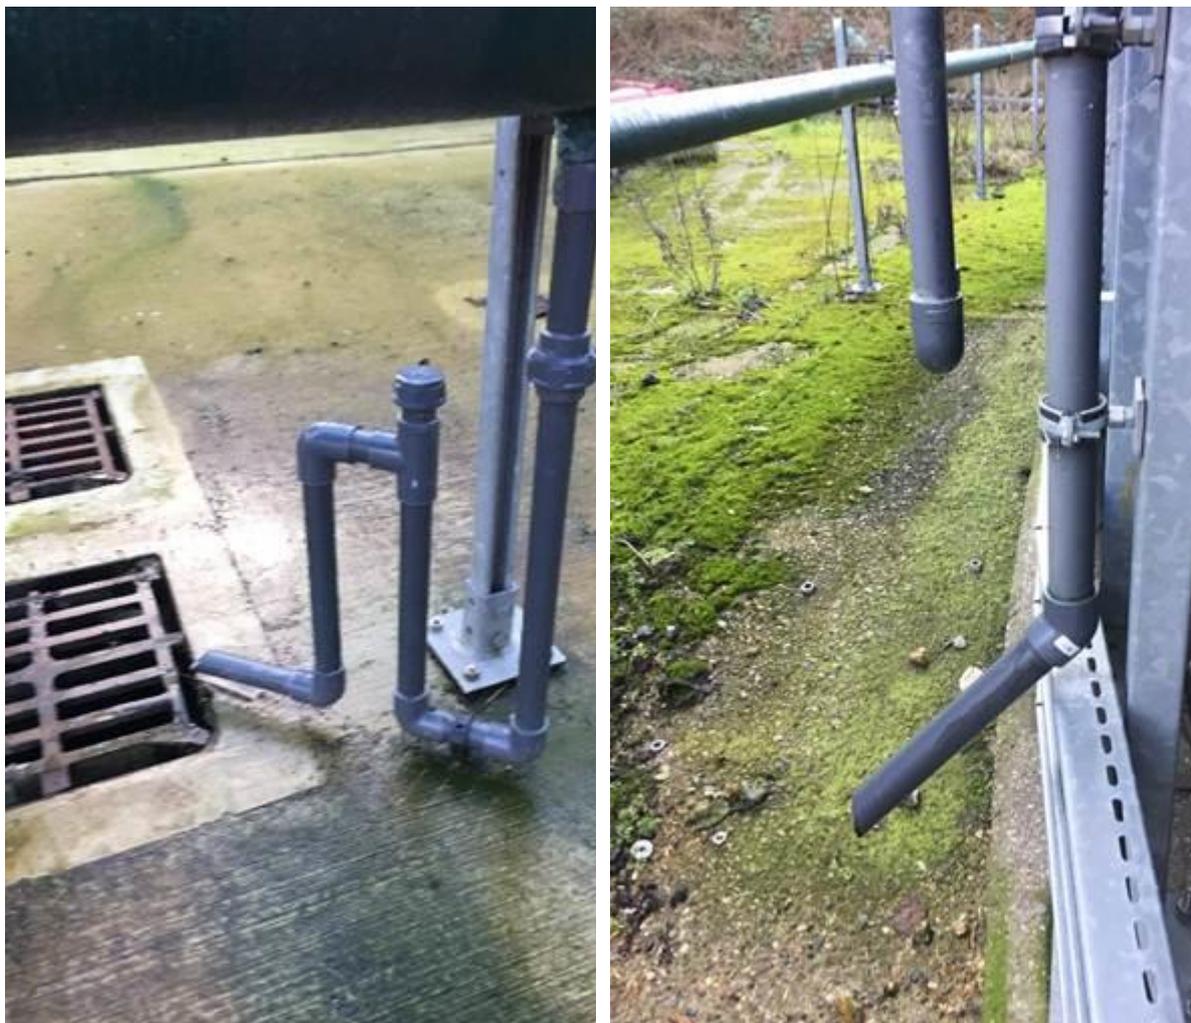
### Install various condensation points

Within the OCU 12 ductwork there was previously points where condensate was escaping from two holes. One hole was allowing condensate to release from ductwork and the second hole was allowing condensate to drip on to cable tray. Two condensation points have been added, one to allow condensate to drain and the other to avoid cable tray. Please see below before & after photos.

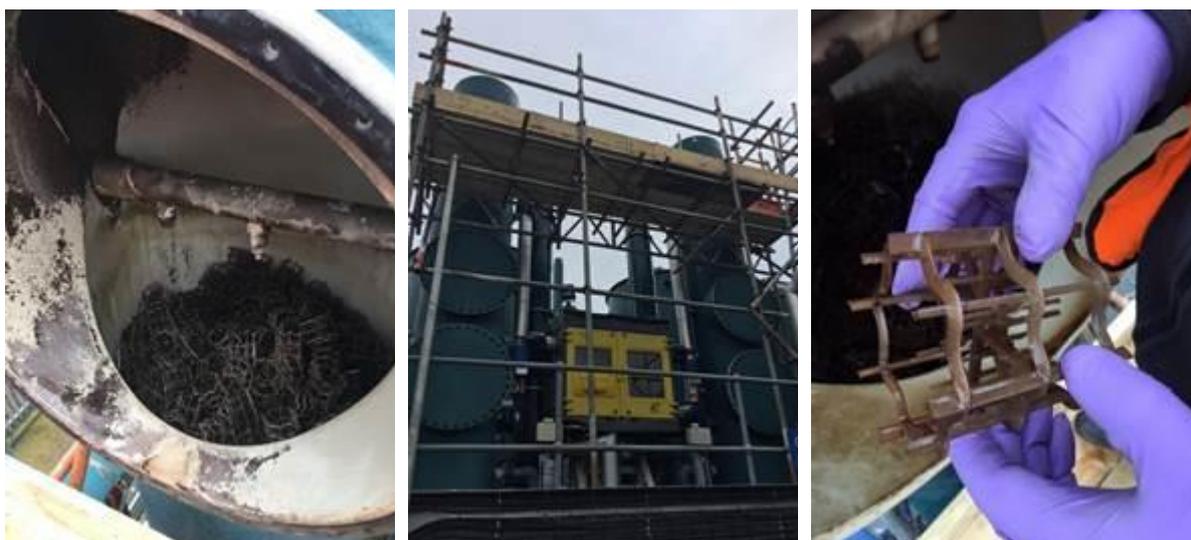
### Clean Quench Tower Internals

On Monday 15<sup>th</sup> February, we had an MTS tanker & site operatives attend site to assist OSIL with the cleaning of the internal packing media inside of the quench towers, this work was then followed with a Caustic IBC setup to circulate the chemical around the quench tower.

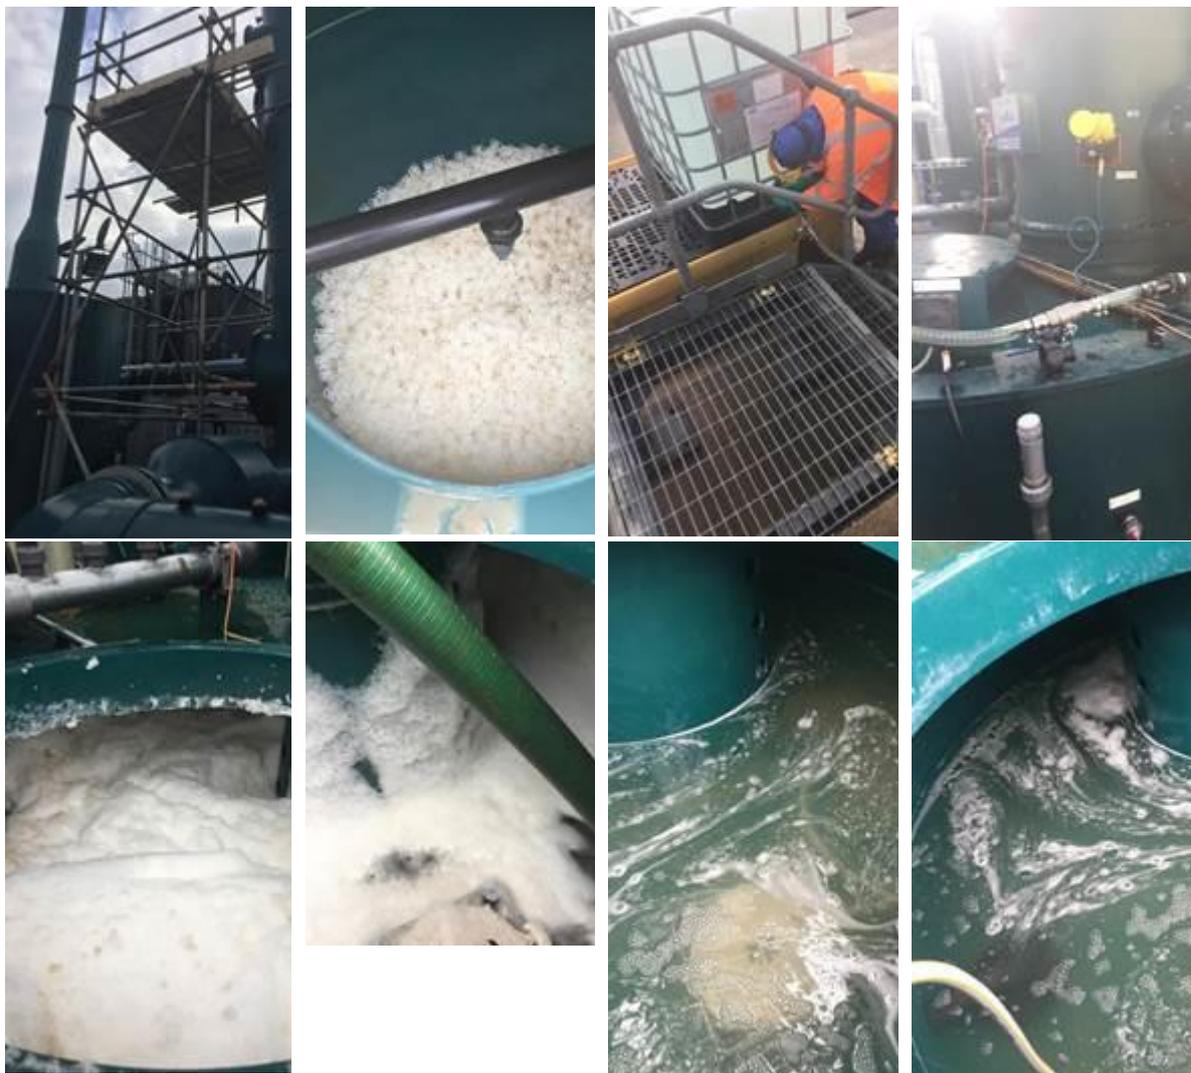
### De-Scale chemical scrubber

Further to the above the MTS tanker and site operatives carried out a pressure jetting from outside of the chemical scrubber vessel at high level from the top hatch, once the jetting was completed from above, the team then moved to empty and jet wash the scrubber sump to remove waste washings. Also, during these works, OSIL setup a chemical IBC of Sulphamic Acid to carry out the de-scale of the chemical scrubber.

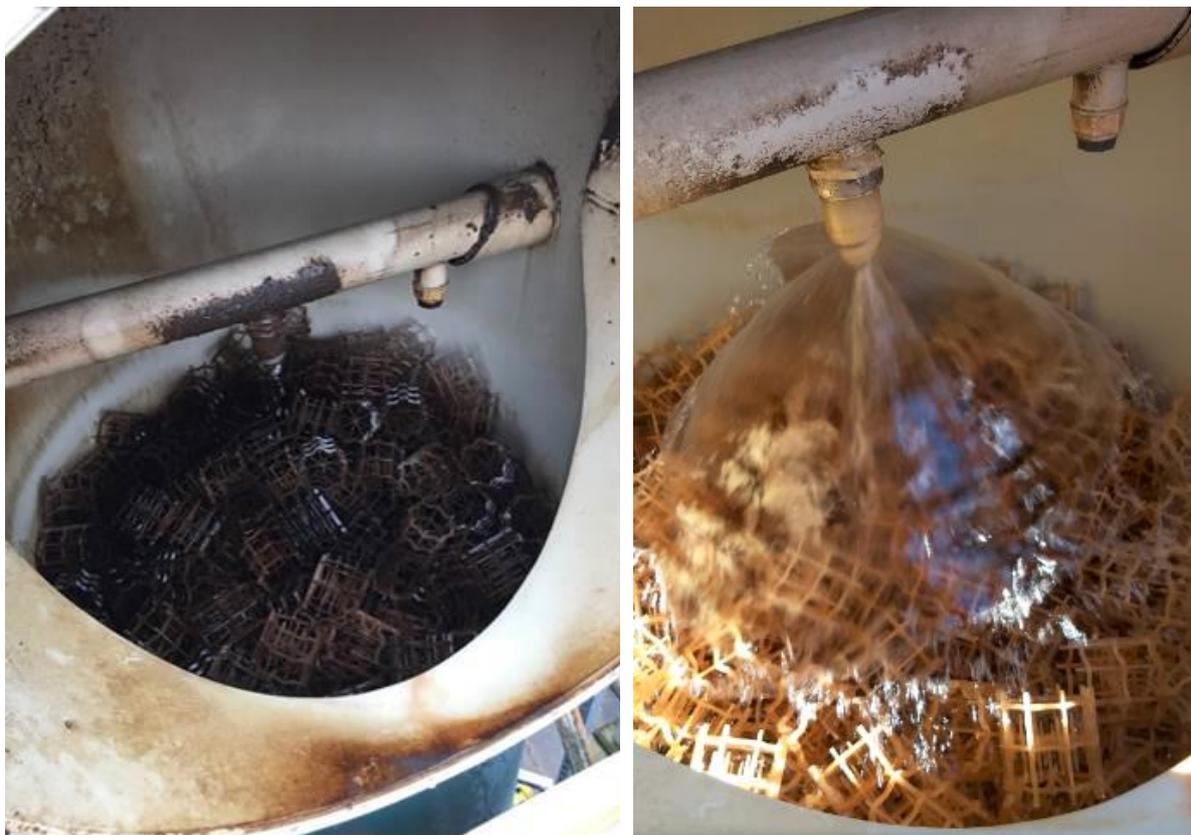
### Quench Tower Internals

The cleans on Quench Tower #1 and #2, respectively, went smoothly using our chemical transfer pump to recirculate the cleaning solution, this provided enough flow and pressure to get a decent spray pattern over the packing media, the below photos highlight the effect the clean had within the towers:

All the quench tower packing media was fully exposed to the caustic cleaning solution so coupled with the jet washing that MTS carried out we can be confident that the overall cleaning efficiency is as good as it could be.

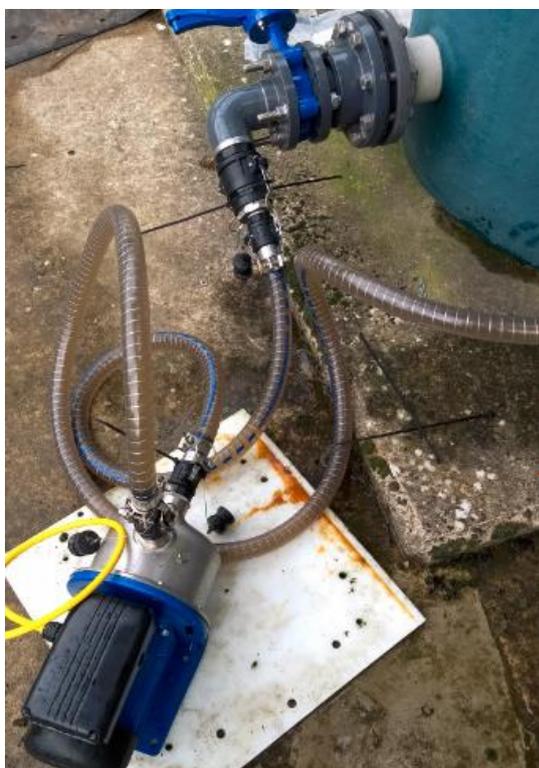
#1 about an hour through the 2½ hours clean:

Based on resultant colour of the cleaning solutions Quench Tower #1 was definitely a lot dirtier than #2 thanks to water damaged FE actuated valve, means #1 had been in service for a lot longer than #2 and hence will have become far dirtier.

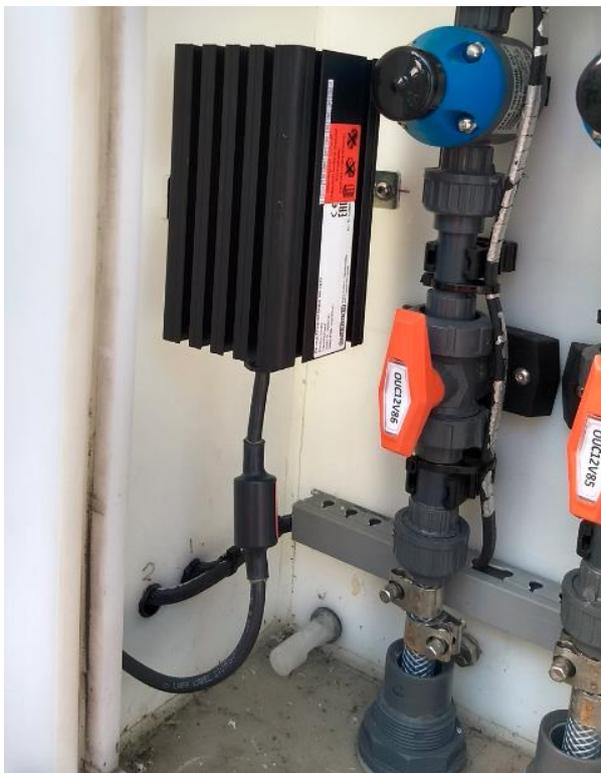
### Caustic POU heater install

100W enclosure heater with Integral 'stat (Intertec CP MULTITHERM DNNA 100 TS10 100W 230V, 10C / 18C stat) mounted at side of caustic POA enclosure using manufacturer's mounting kit and stainless-steel machine screws drilled and tapped into enclosure rear wall:

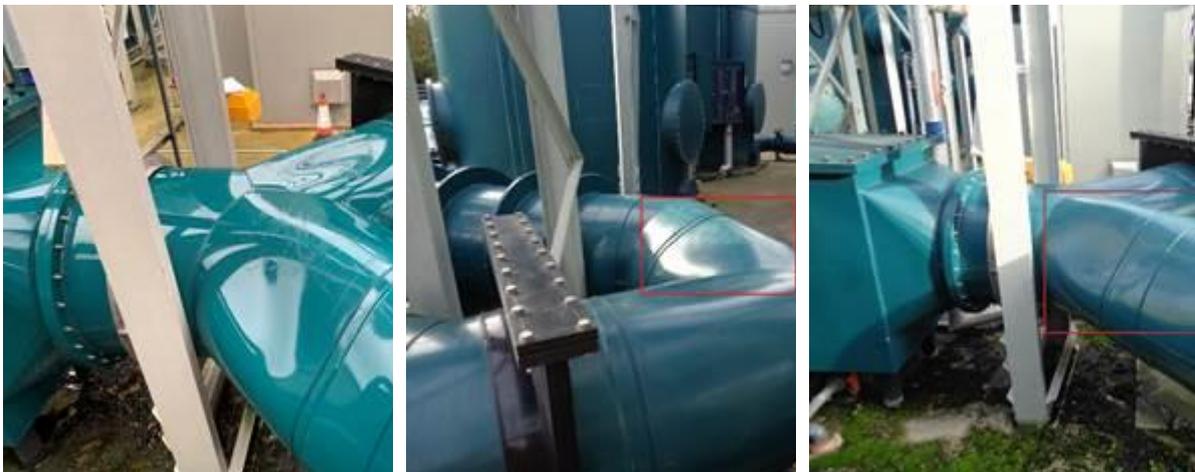
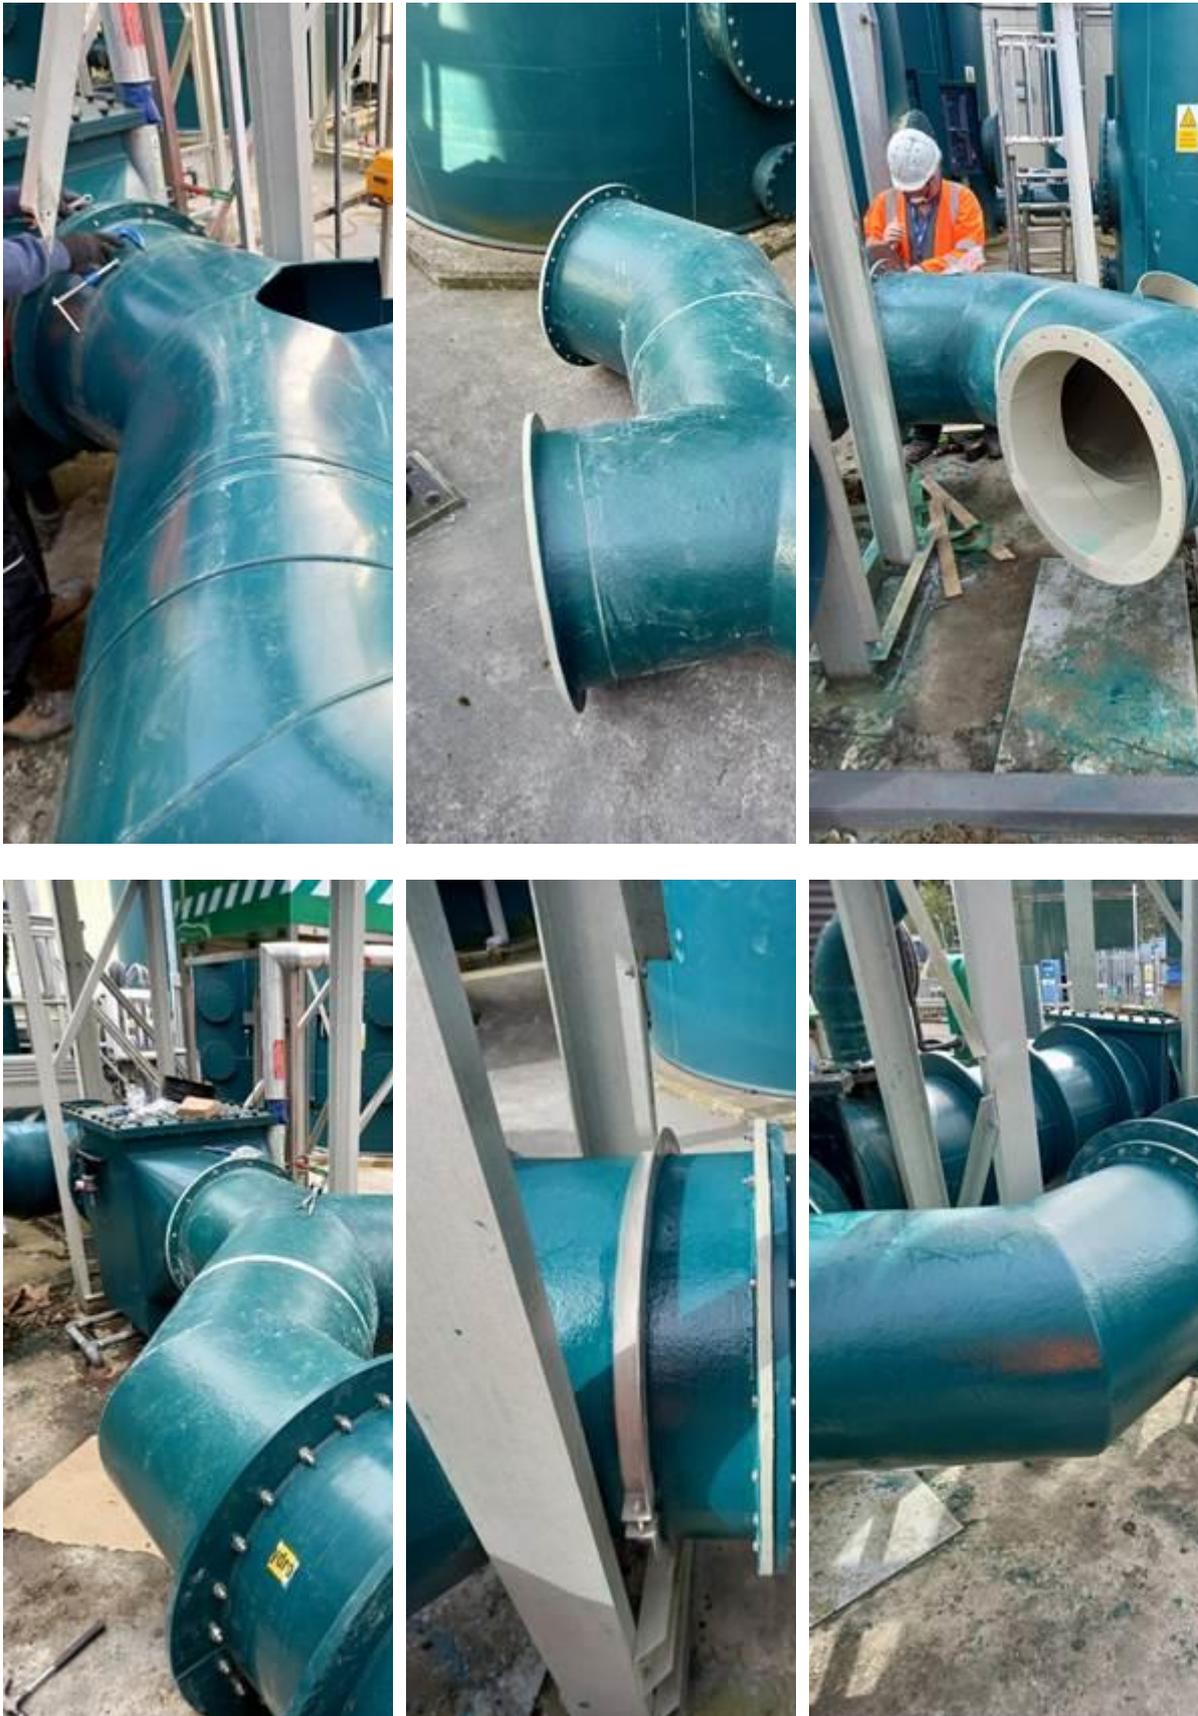
### **Replace deformed inlet ductwork**

Further to the shutdown requests between 7:30 a.m. to 5 p.m. on Tuesday 23<sup>rd</sup> & Wednesday 24<sup>th</sup> March the OSIL site team were able to remove the existing deformed Y-piece ductwork on the outlet of the fans and install a new Celmar/GRP Y-piece in place, the below photos show the newly installed ductwork which has been strengthened to stop future deformation from happening.

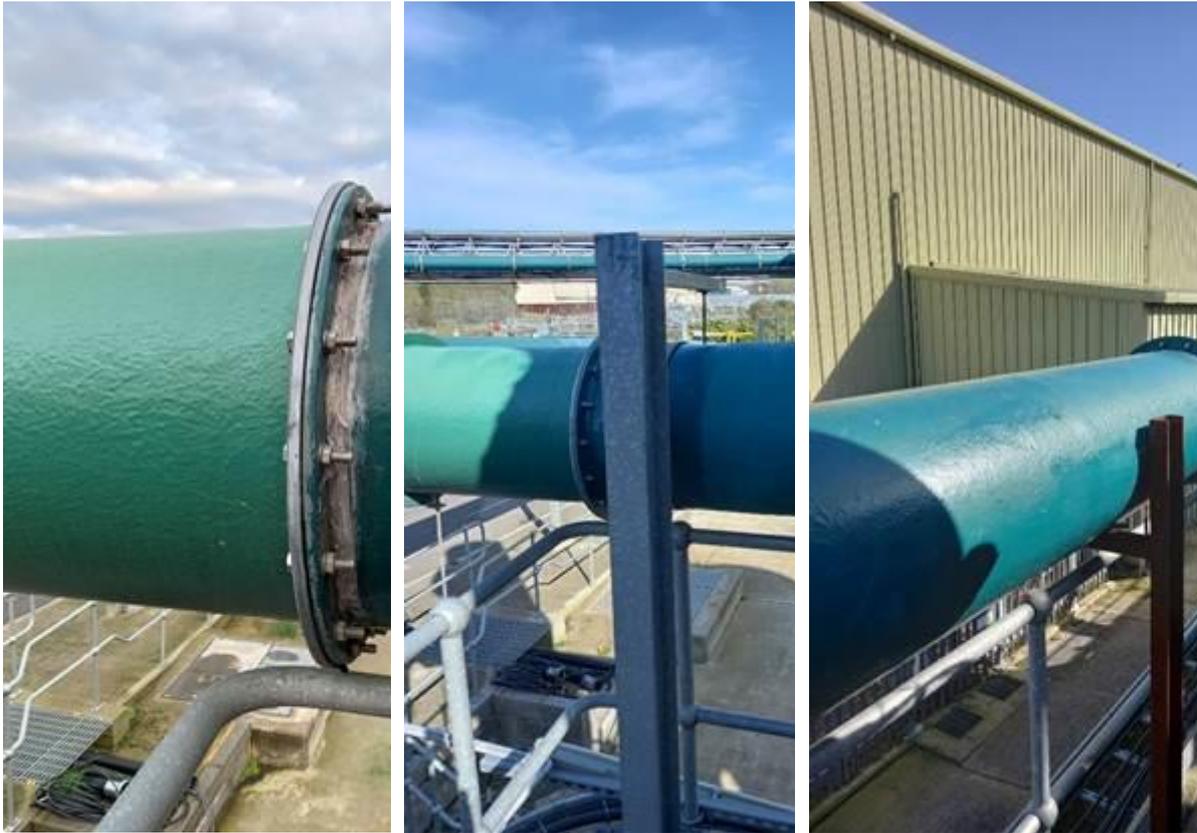
### Repairs to ductwork

On the ductwork where the PAS airstream comes into the Quench Towers there was a damaged flange where previously you could hear the air whistling into the cracks that had formed. The site team cut away the damaged flanged connection and installed new flange piece complete with

internal slips to repair the ductwork which is now completely sealed. Please see below photos of the repair:

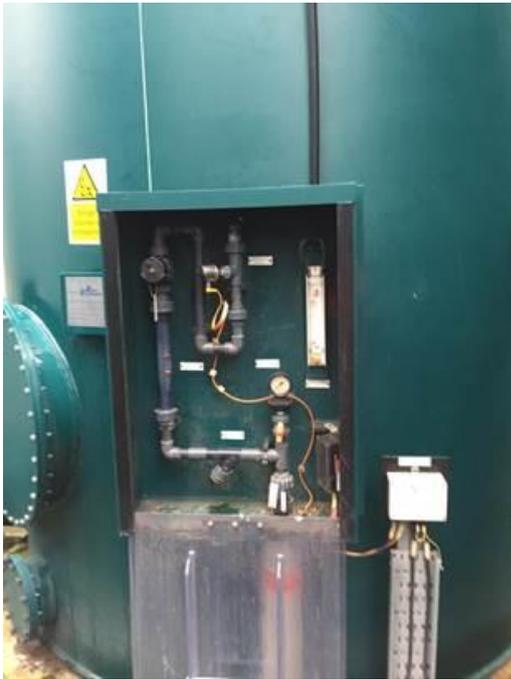
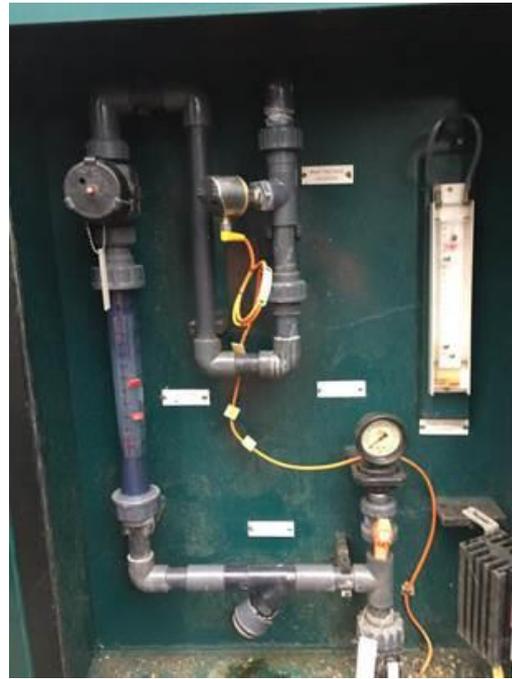
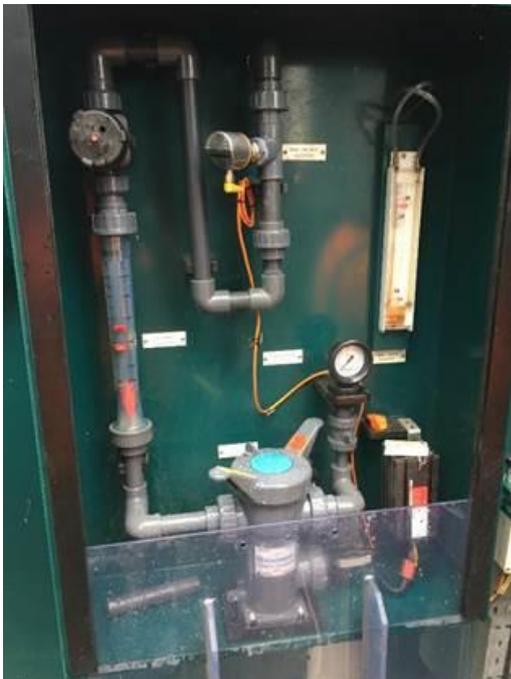
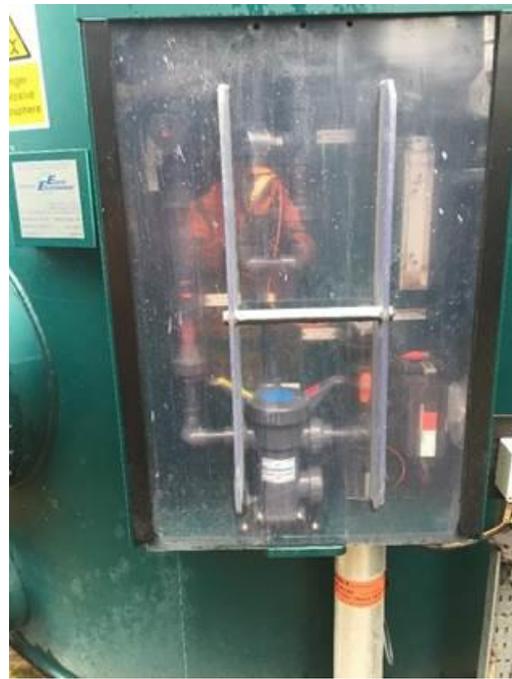
### Install larger in-line filters to Biofilter

Since OCU 12 was initially installed at Mogden the effluent feeding the Biofilters has consistently had issues with snail larvae within the irrigation stream which resulted in the existing Y-strainers in the 8-off Biofilters becoming blocked almost always within a few hours after cleaning. OSIL therefore upgraded the existing in-line filter setup, the logic for our selection of the 1½" basket strainer is that the existing y-strainers have a capacity of around 25ml whereas the new basket strainers have a capacity around 2,500ml i.e. will hold around 100 times as many snails and extend the couple of hours to clog to couple of hundred hours so maybe a weekly clean by Thames would ensure continuity of FE irrigation (and hence bio-filter performance) i.e. hours now become days.

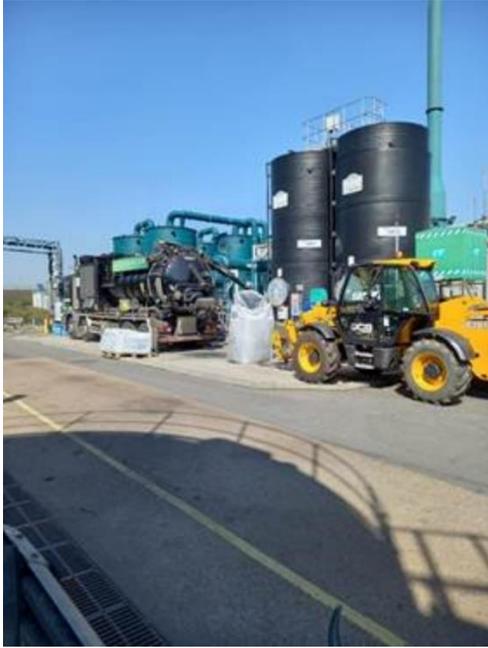
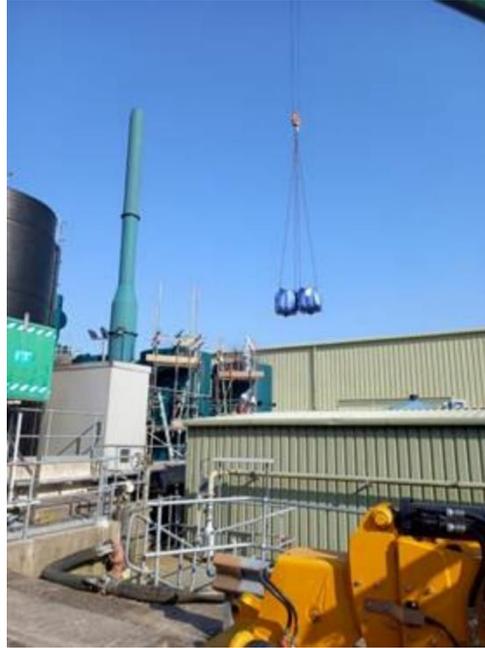
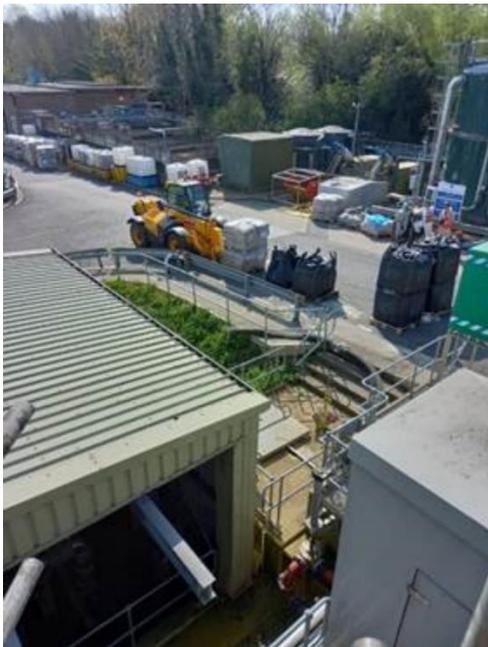
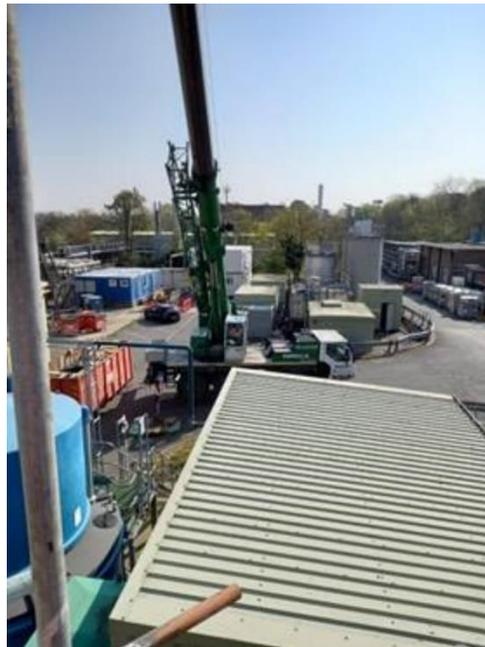
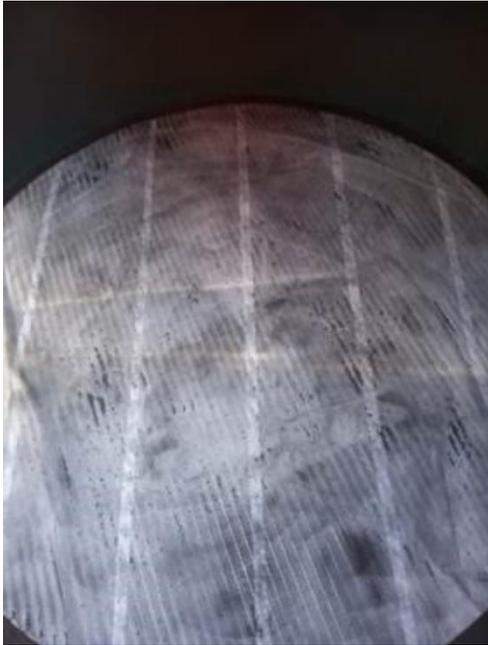
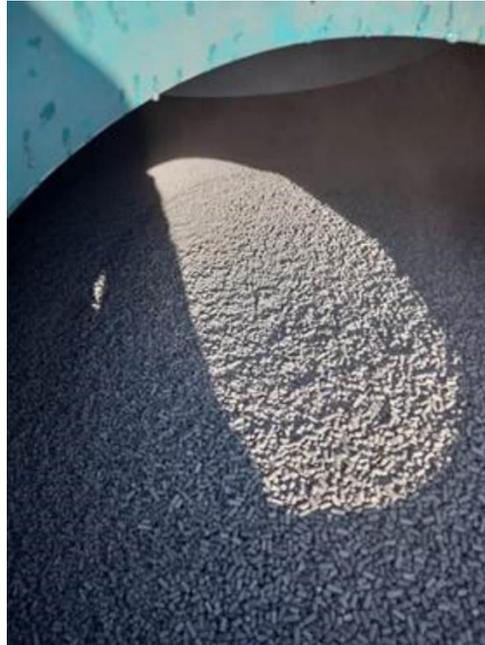
### OCU 12 – Carbon Media Change

Monday 19<sup>th</sup> April – Disab Vacuum Tanker setup and suction hoses setup to remove the existing spent carbon media within the 4 filters – approx. 43m<sup>3</sup> of media was removed in total (4 filters, with 5.38m<sup>3</sup> in top & bottom section). The new carbon media was then also delivered & offloaded via curtain sider on this day.

Tuesday 20<sup>th</sup> April – New carbon media refill with bulk bags completed in top section of filters, these works were assisted by Emerson Crane Hire who were used to carry out a contract lift to aid with refilling of the carbon media bulk bags.

Wednesday 21<sup>st</sup> April – Completion of the new carbon media refill works with small (20kg) bags in lower section of filters.

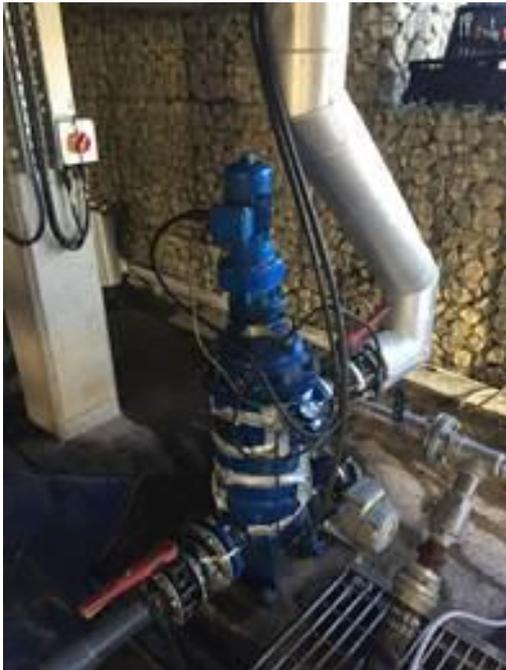
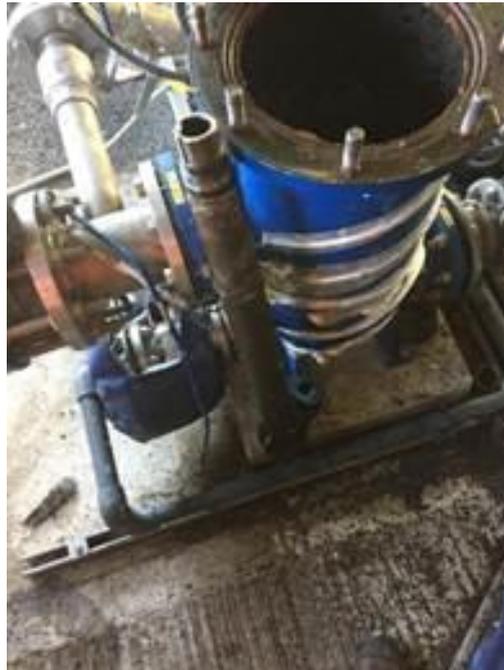
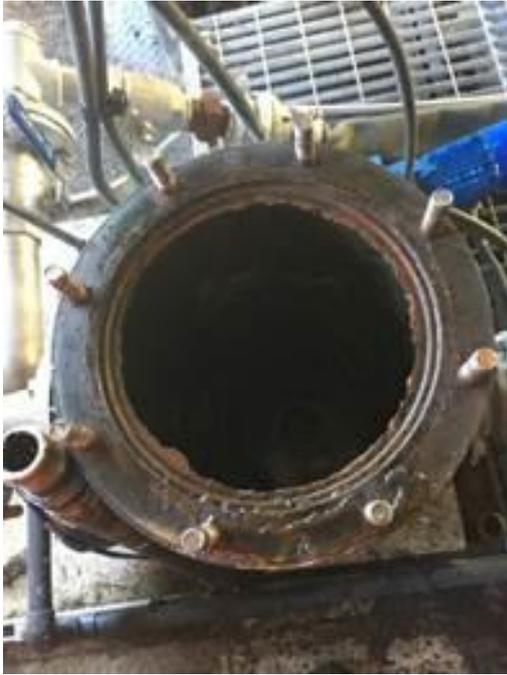
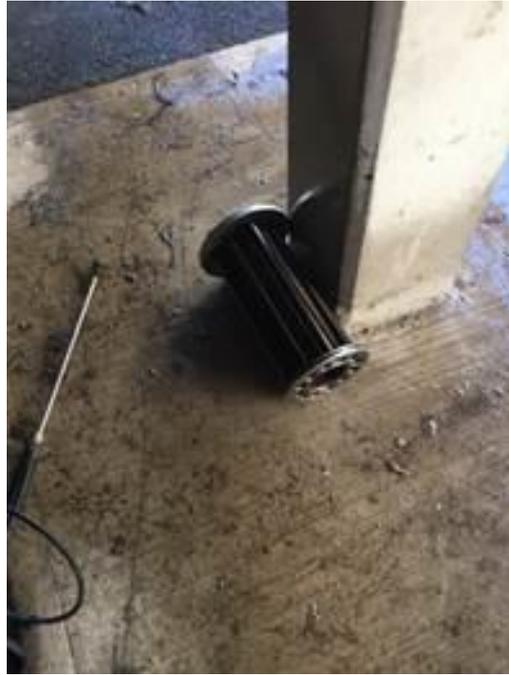
### **Bollfilter Service on OCU 12**

During our chemical cleaning works of the OCU 12 scrubber & Quench Towers, OSIL found that the FE supply pressure for OCU12 was low and not consistent and this was down to the boll filter being sat constantly cleaning and dumping to drain (so a significant percentage of the incoming pressure was being lost to drain). Due to the submersible pumps staying on the Thickener system, it was agreed to use these budgeted works to undertake a Bollfilter service on OCU 12 to resolve the reported issues, this was completed on Friday 26<sup>th</sup> February with Bollfilter service engineer Liam Fitzpatrick. Photos below from Bollfilter service:

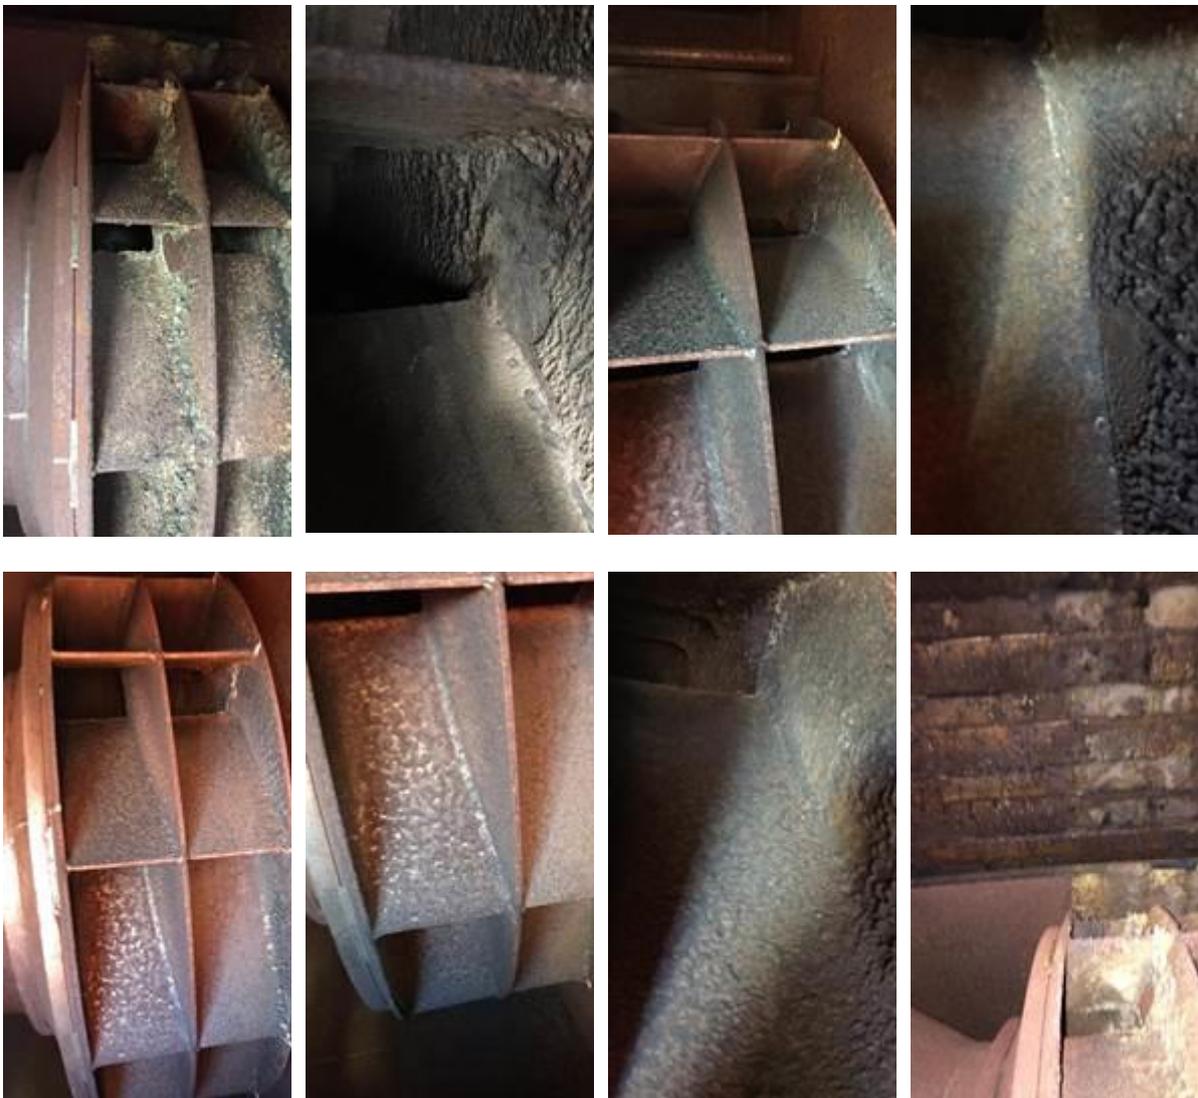
#### Clean Fan Impellers

Wednesday 24<sup>th</sup> February, prior to the cleaning our Team recorded the significant scale that had built up on the impellor blades, photos below for reference show pre-cleaning:

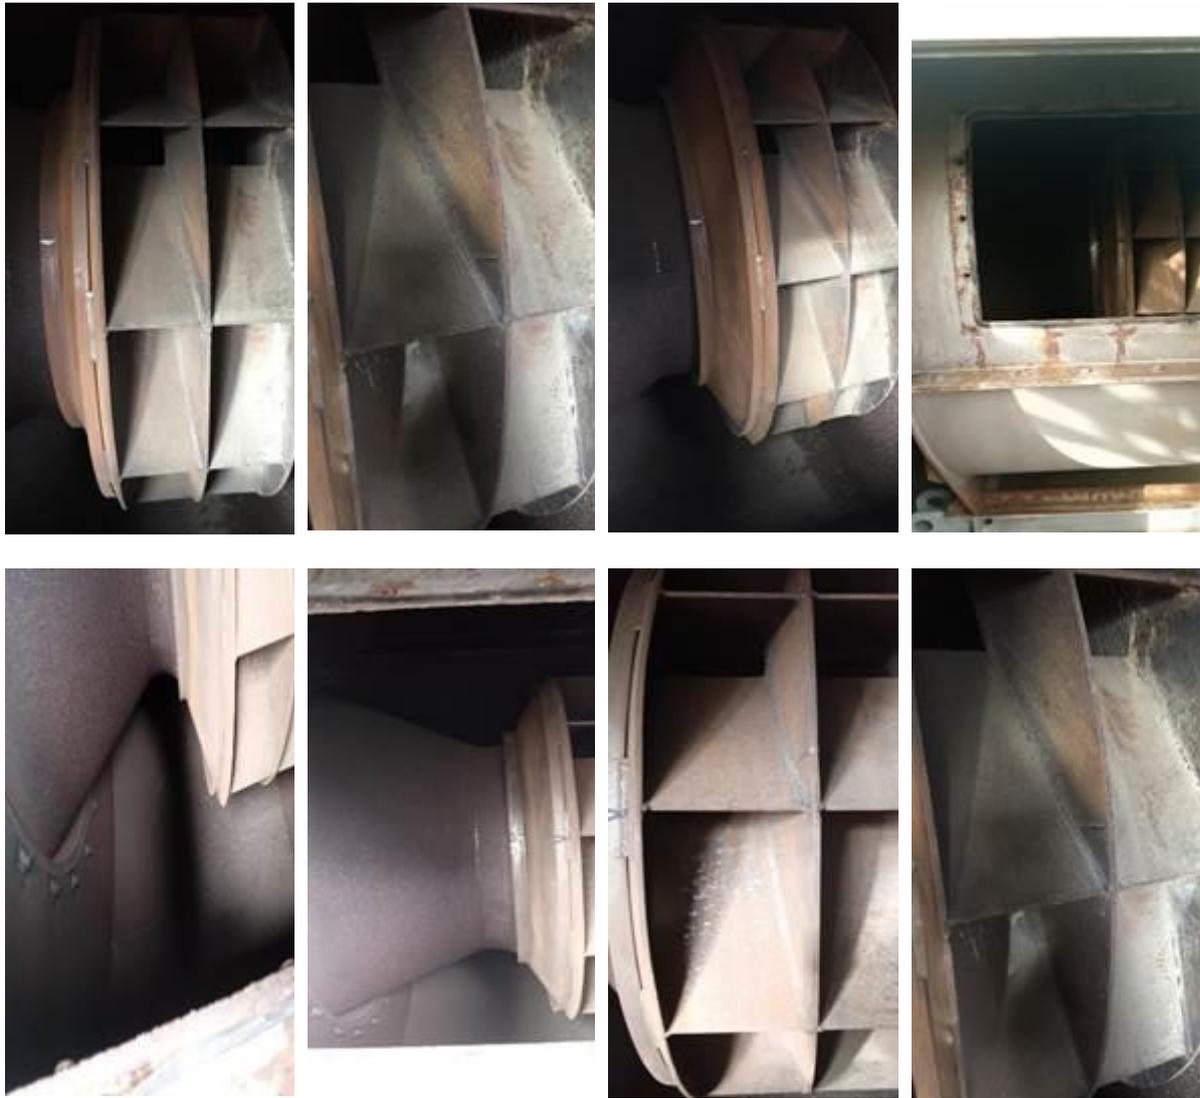
The site team then used an industrial scraper, wire brush and hot pressure washer to then remove the scale from the impellers, photos below for reference show post-cleaning:

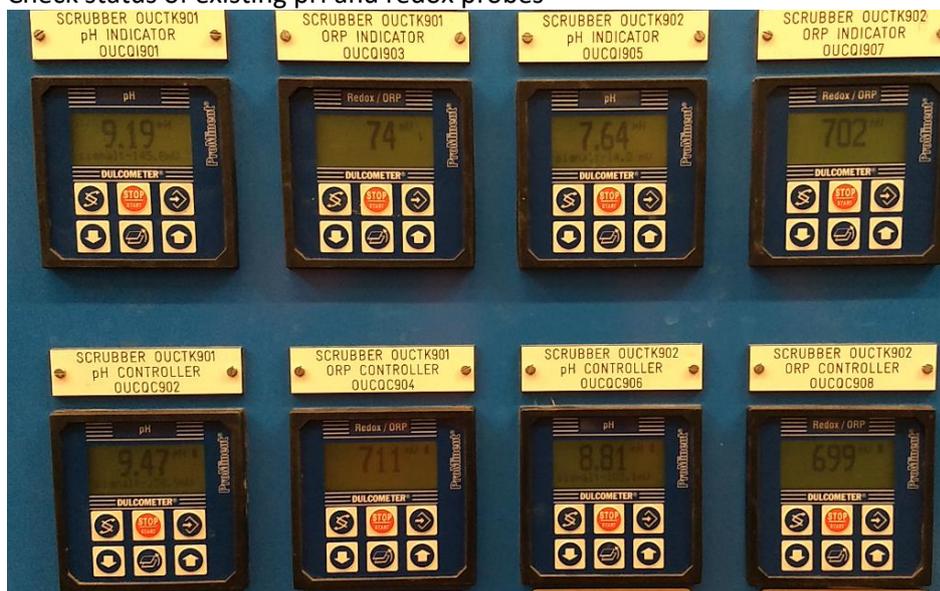
### OCU pH and redox probe swap

Check status of existing pH and redox probes –

Scrubber #1 pH – two instruments showing 0.28pH difference, not ideal but not sufficient to inhibit automatic dosing.

Scrubber #1 redox – two instruments showing 637mV difference with OUCQ903 reading very low, automatic hypo' dosing inhibited by this large difference (>50mV alarm setpoint).

Scrubber #2 pH – two instruments showing 1.17pH difference, automatic caustic dosing inhibited by this large difference (> pH 0.5 alarm setpoint).

Scrubber #2 redox – two instruments showing 3mV difference which is almost perfect correlation suggesting probes are in perfect condition.

- Removed existing pH probes from Scrubber #1 (Note OUCQC902 had wrong probe installed (Grundfos) and installed replacements (Prominent PHER 112 SE). Calibrated using single use sachets of pH 7 and pH 10 buffers (Note OUCQI901 incorrectly set to use pH 7.06 as buffer #1 and OUCQC902 incorrectly set to use pH 10.15 as buffer #2, reset to correct pH 7 and pH 10 values, respectively). Both Calibrated OK (OUCQI901 : Zero = 9.8mV, slope = 59.67mv/pH and OUCQC902 : Zero = -6.2mV, slope = 57.57mv/pH).

- Removed existing redox probes from Scrubber #1 and installed replacements (Prominent RHER PT SE). Calibration check undertaken with fresh 465mV redox standard. OUCQI903 read 74mV (as with old probe) and reported as a defective sensor. However, given than both the old probe and the new replacement gave exactly the same reading I suspect the fault actually lies elsewhere in the redox measurement circuit. Our gut feeling is that the module that screws onto the redox probe and converts the redox value to a 4-20mA signal which is measured by the instrument in control panel is faulty. This will be easy to prove by replacing the probe and module with a 4-20mA loop simulator. If the result redox value varies correctly in response to simulated 4-20mA signal then the module is faulty. If it sticks at 74mV then the fault lies in the instrument itself.

- After Scrubber #1 probe replacement, automatic hypo' dosing was still inhibited due to incorrect low reading from OUCQI903 giving rise to difference between redox values > 50mV alarm setpoint. Temporarily changed redox difference alarm setpoint to 1,050mV to mask the issue with OUCQI903 and hence to allow automatic hypo' dosing to recommence. Please note that in doing so, the control system will no longer be able to detect an issue with OUCQC904 and so there is a finite risk of under or overdosing hypo' until the issue with OUCQI903 is addressed and the redox difference alarm setpoint restored to correct 50mV setpoint value.

- Removed existing pH probes from Scrubber #2 (Note OUCQC902 had wrong probe installed (Grundfos) and installed replacements (Prominent PHER 112SE). Calibrated using single use sachets of pH 7 and pH 10 buffers (Note OUCQI905 incorrectly set to use pH 10.07 as buffer #2, reset to correct pH 10 value). Both Calibrated OK (OUCQI905 : Zero = 14.7mV, slope = 55.44mv/pH. OUCQC906 : Zero = -18.7mV, slope = 57.34mv/pH).

- Removed existing redox probes from Scrubber #2 and installed replacements (Prominent RHER PT SE). Calibration check undertaken with fresh 465mV redox standard. Both read correctly (OUCQI907: 460mV and OUCQC908: 456mV).

- After Scrubber #2 probe replacement, automatic caustic dosing was correctly reinstated as pH difference was now < pH 0.5 alarm setpoint. So on completion of probe swap auto dosing has been fully restored to both scrubbers.
