## CASE STUDY

Thames Water, Mogden STW

OCU REFURBISHMENTS 2021

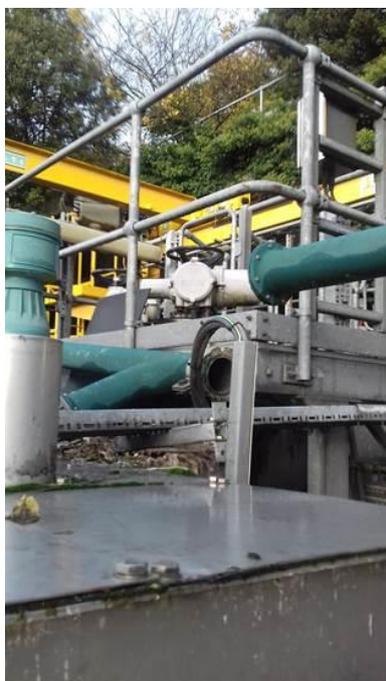
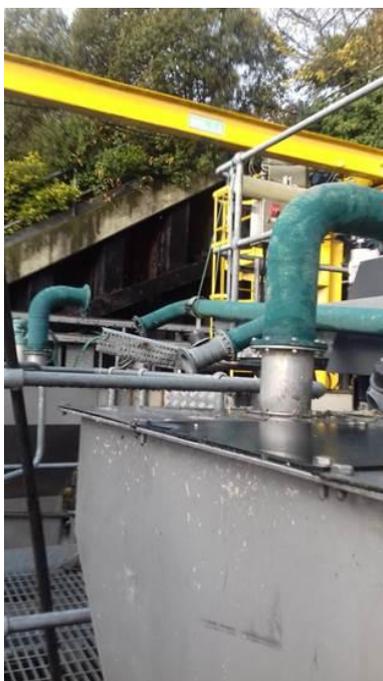
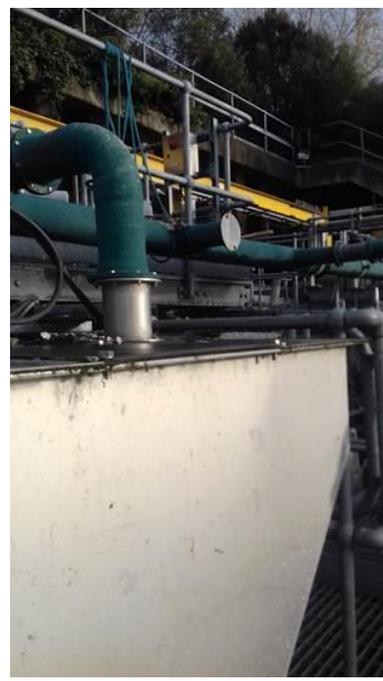
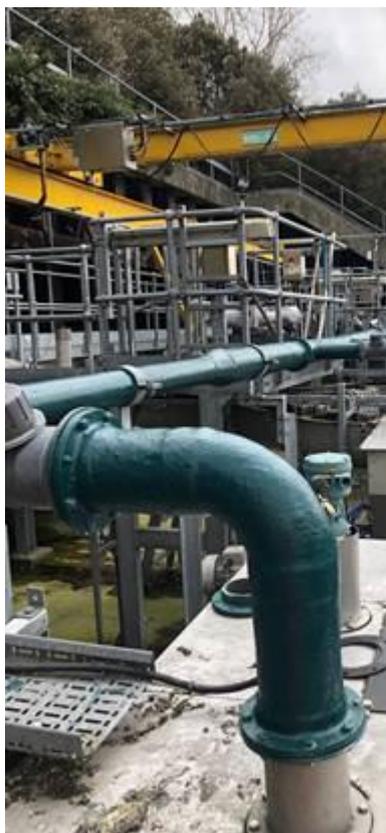
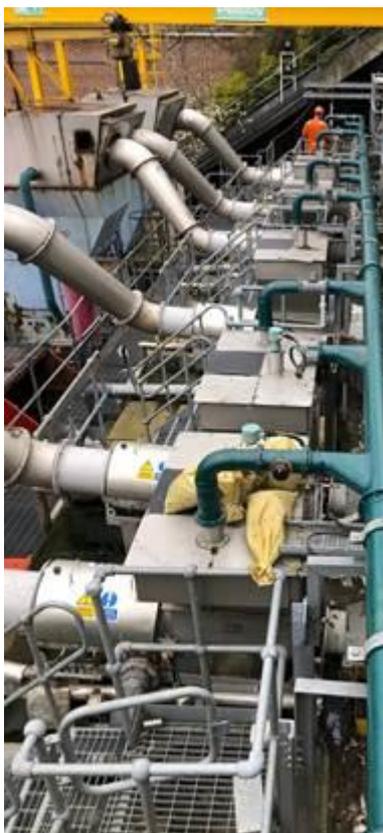
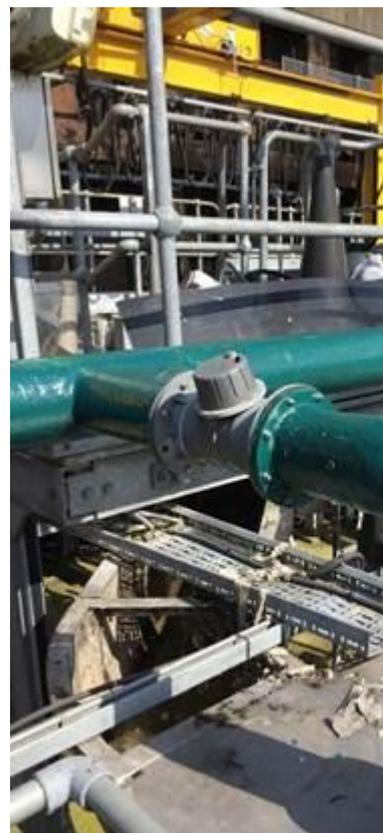
### Repairs to inlet screen ductwork and dampers

Various ductwork sections & volume control dampers were previously removed from the inlet screens, the OSIL team reinstated these sections/dampers and re-fibre glassed the ductwork to further protect from UV deterioration.

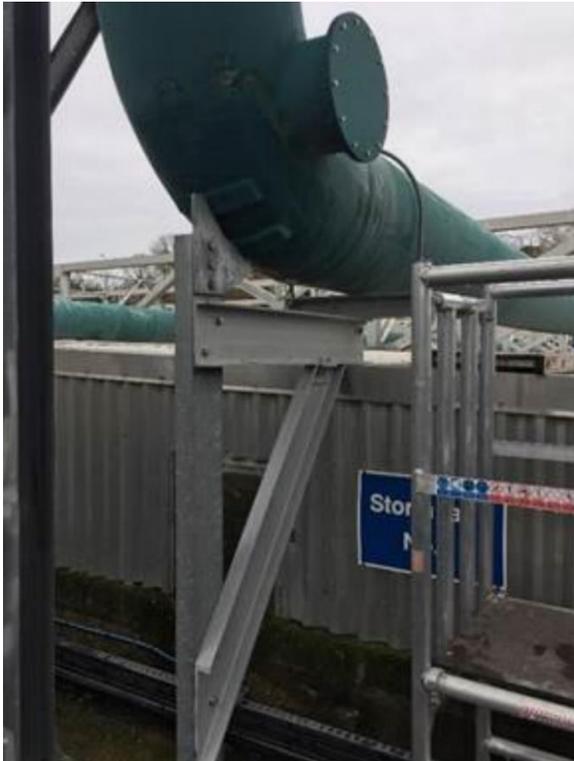
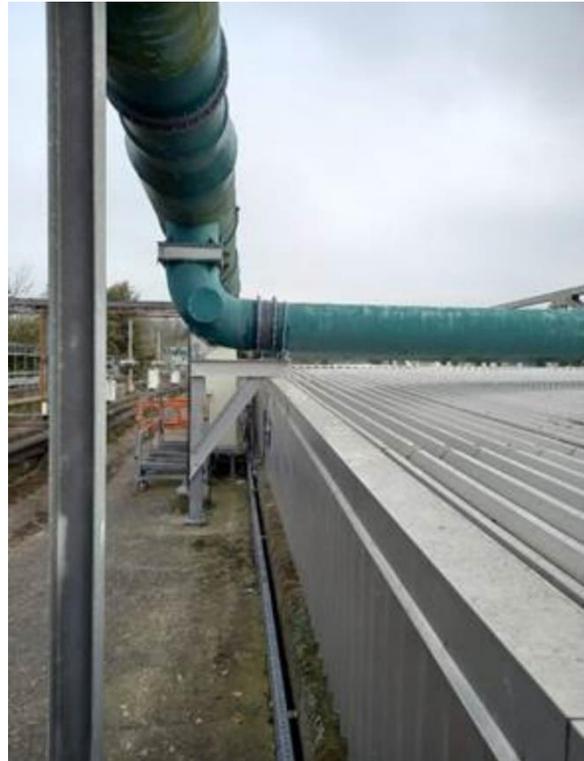
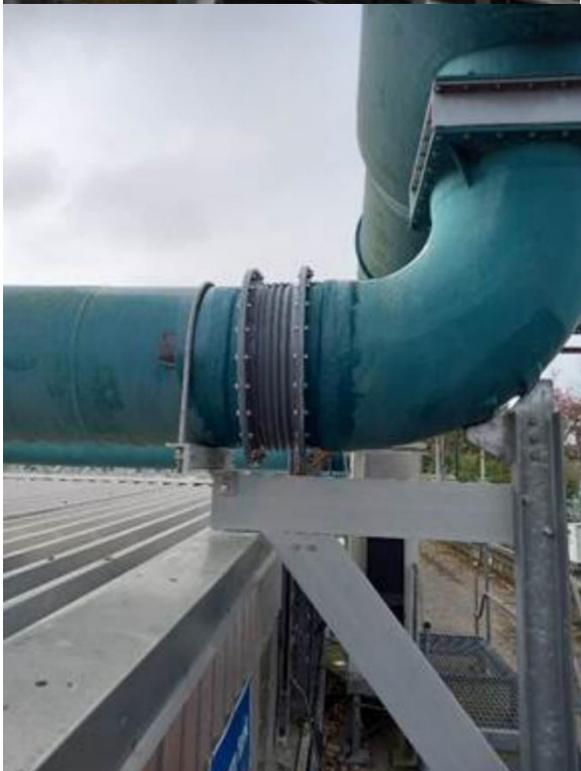
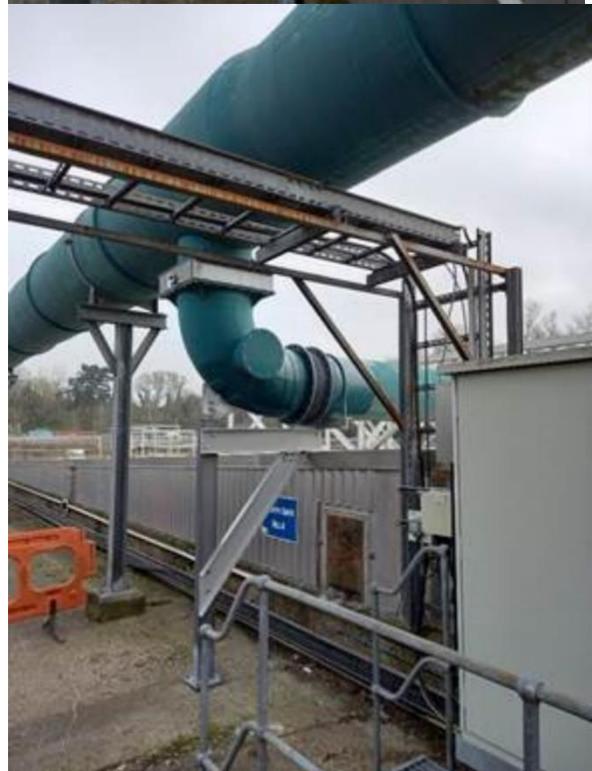
### Expansion joint fitted to critical ductwork lines - storm tank area (2 off)

Further to works carried out on previous refurbishment schemes at Mogden, two more flexible expansion joints have been installed into the storm tank area ductwork lines, we have also manufactured two GRP supports to support the new expansion joints, please see below photos:

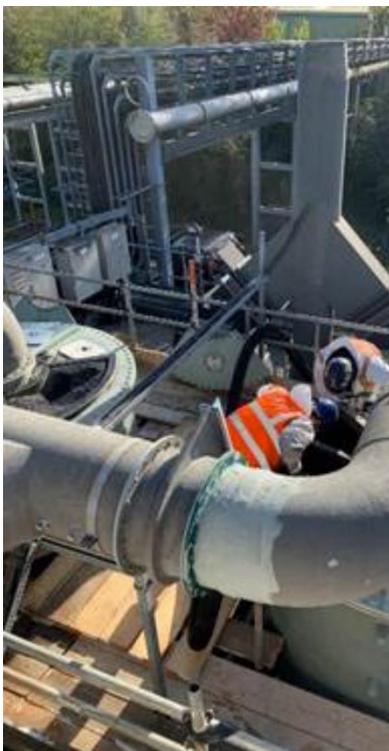
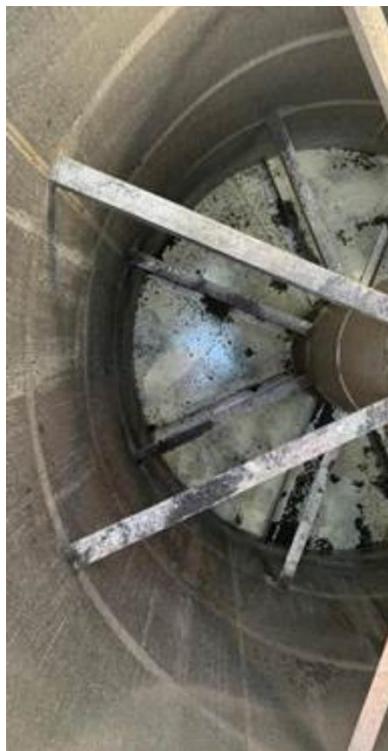
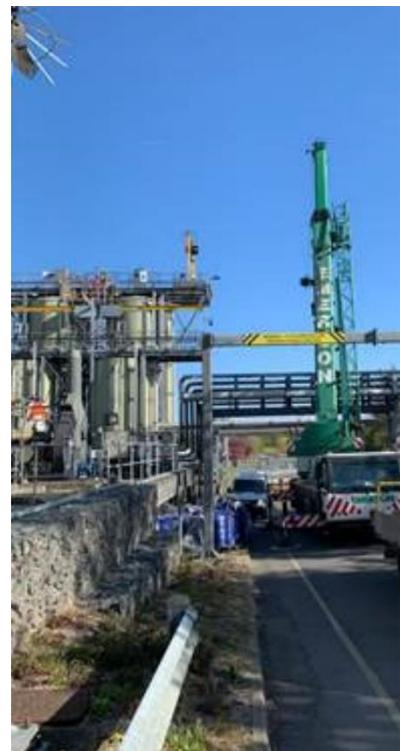
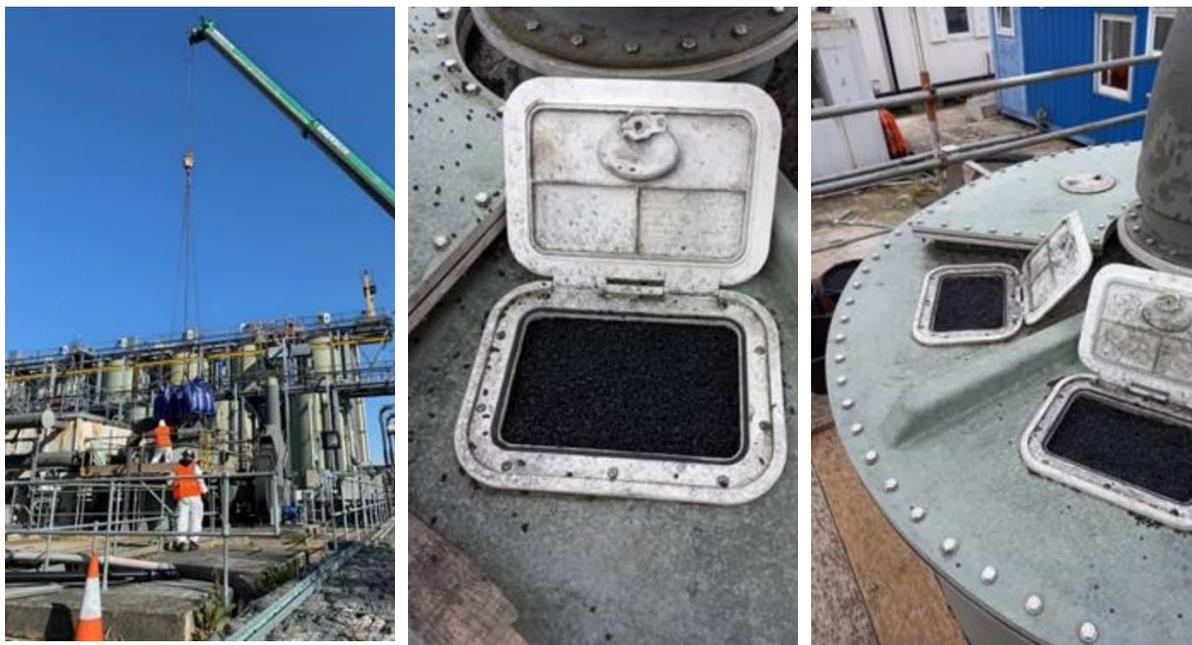
### Change carbon media in two CuCarb units

Thursday 22<sup>nd</sup> April – Disab Vacuum Tanker setup and removed the existing carbon media from both the Thickening OCU carbon filters – approx. 14m<sup>3</sup> in total (2 filters with 7m<sup>3</sup>). Curtain Sider and flatbed transport also came to collect all the bagged waste media removed from the Thickening OCU to return to the regen plant. The new Thickener OCU media was also delivered & offloaded.

Friday 23<sup>rd</sup> April – New carbon media was refilled with bulk bags via the top access hatches on the filters and distributed evenly in the filters until full, again these works were assisted by Emerson Crane Hire who were used to carry out a contract lift to aid with refilling of the carbon media bulk bags.

- In addition to the above, OSIL were also audited on site during the works and provided Thames with all documentation as requested i.e. crane permits, TWOSA, signed daily activity briefing and signed RAMS, ensuring everyone who was involved in the task had worked to the correct procedures and the appropriate work permits were in place.
- Photos of Thickening media change works as below:

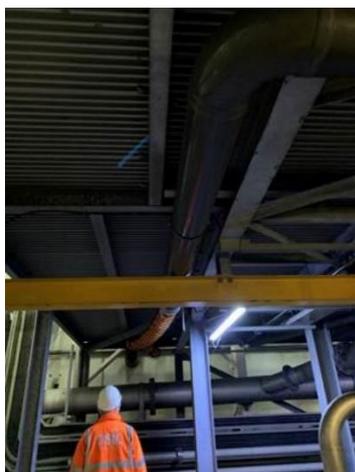
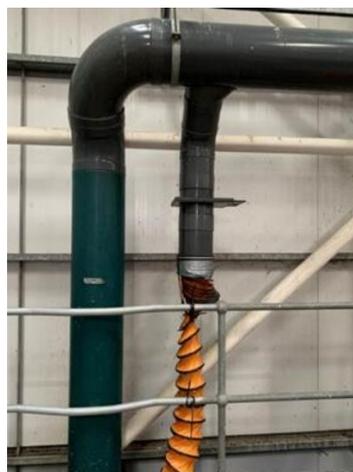
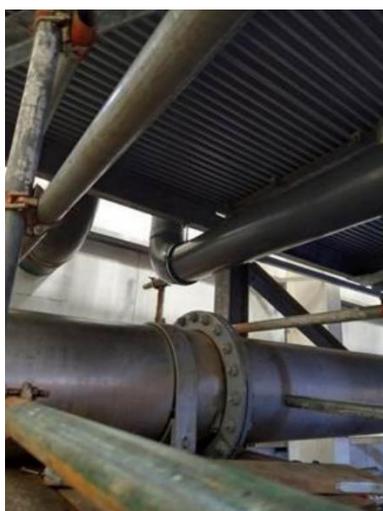
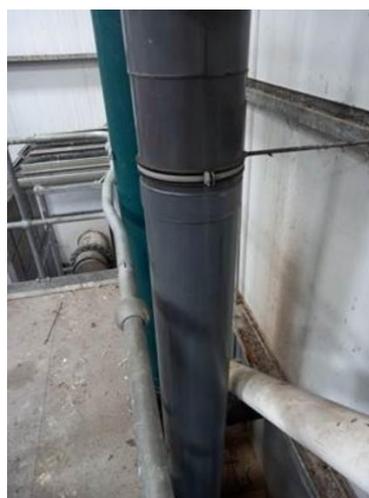
### Thickener building - replace temporary ductwork

Temporary ducting which had been installed by others was replaced by the OSIL site team with new uPVC ductwork sections to fit the existing plastic pipe within the thickener building, please see below before & after photos:

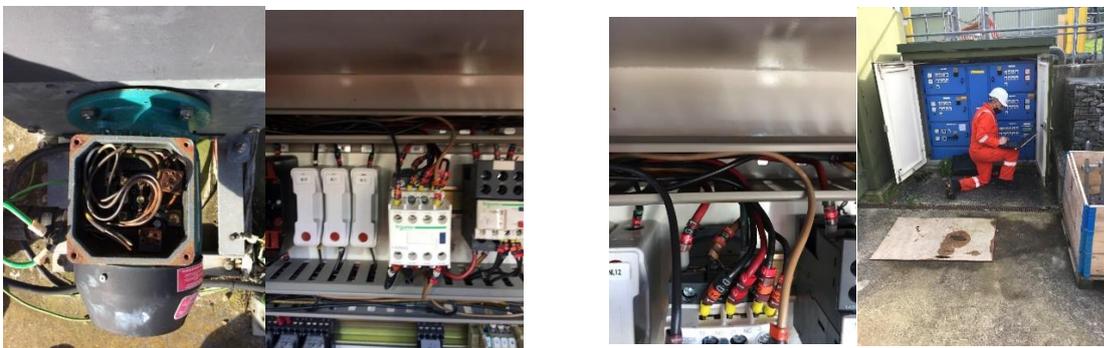
### Photos from Site Works:

During OSIL's initial attempt to implement a modified control logic in the existing LCP it was discovered that both the PS14 control panel & fan motor had suffered from extreme heat & burn out. The software modification has been implemented into the control logic however could not be tested at the time due to heat damage found within the panel & fan motor.

OSIL then programmed two engineers from TES Controls Ltd alongside us to then carry out the required panel remedial works and cabling/testing of the new fan motor.

1. All 3 phase cables replaced within Fan No. 1 cubicle. Contactor replaced with a 12 Amp 110vAC coil, Thermal overload Relay replaced.
2. 7 core 2.5mm cable replaced with new and ATEX glands between Isolator and Motor.
3. It was noted when testing that the Motor Isolator had a pole not operating. This was used for the Heater 230v supply line. Also, the lid was leaking. The Isolator body and lid were replaced with an unused Isolator off the Thickener Fans.
4. The Contactor within Fan 1 starter cubicle was fitted with a 100vDC coil, whereas it should have been 110vAC. Not sure if this would of / or has ever worked.
5. Fuses within the Cubicle Isolator have been changed to 32M40, Motor rated fuses. The schematic diagrams state these should be 16Amp.
6. Updated software loaded and Fans tested for rotation and operation on failure.
