CASE STUDY

Birkenhead – United Utilities (Costain) OCU REFURBISHMENT

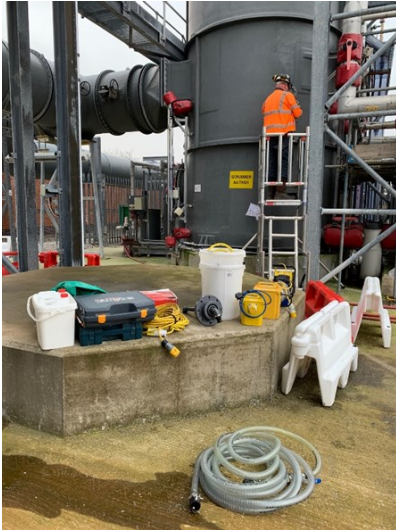
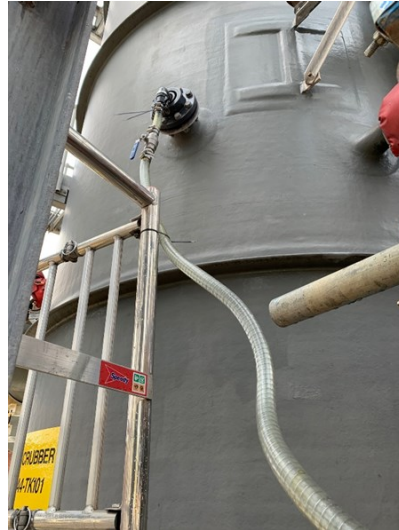
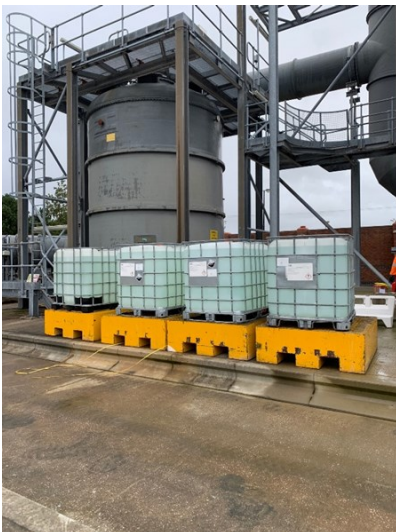
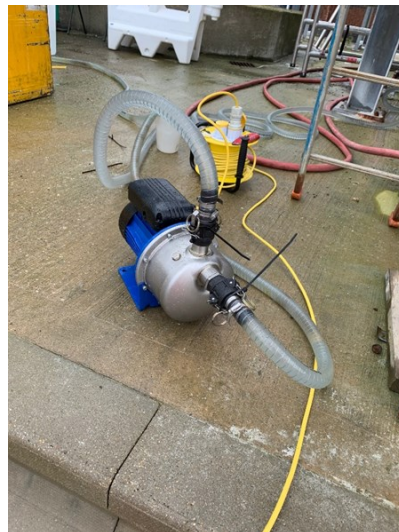
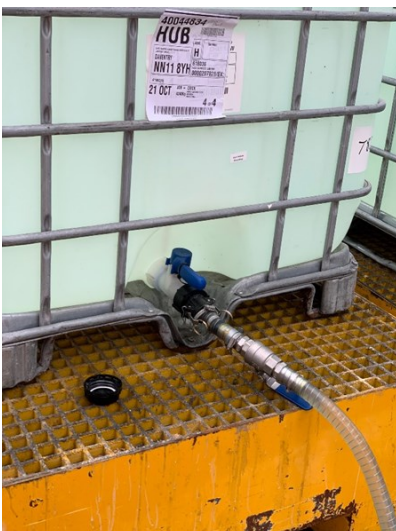
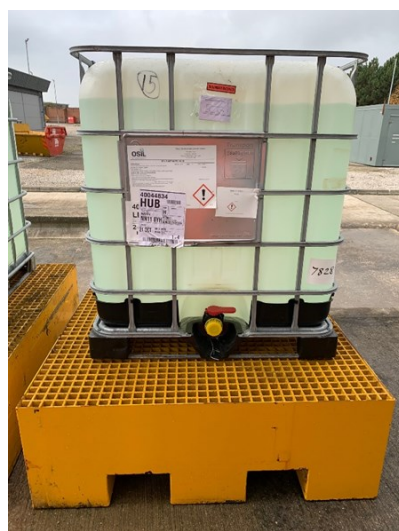
Acid clean of recirc lines, inline filters, and instrument lines

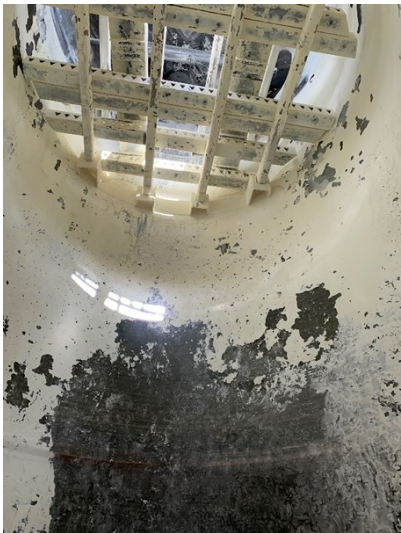
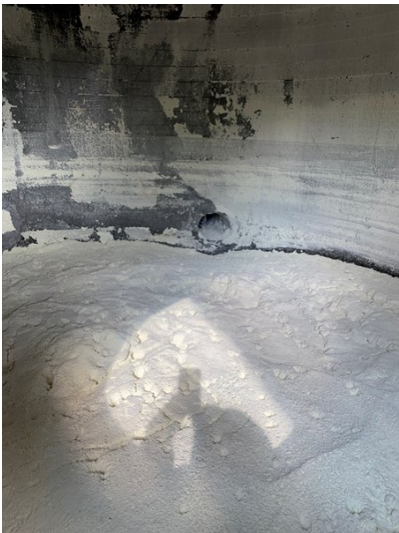
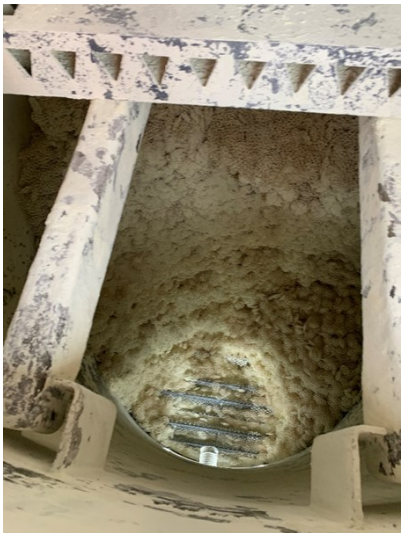
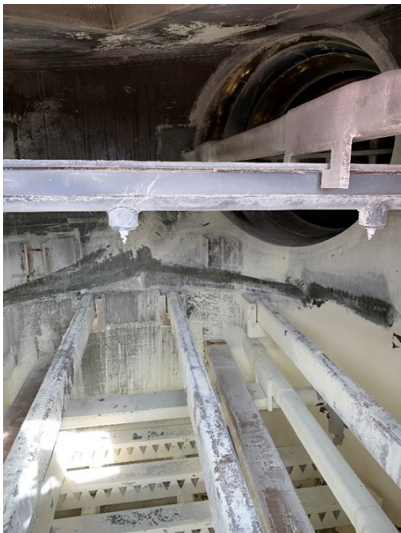
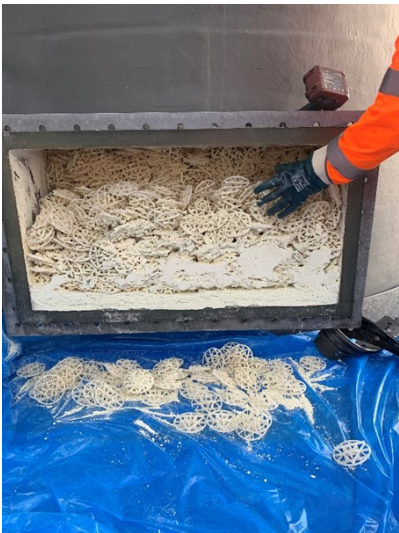
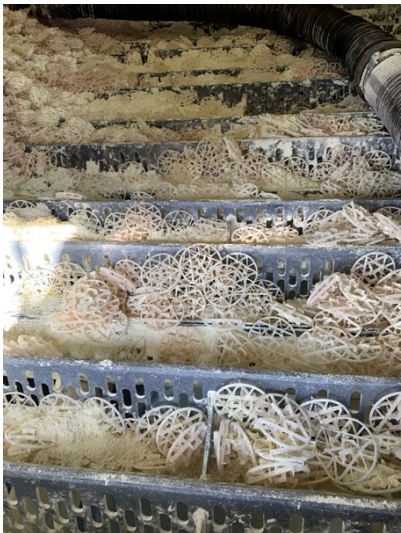
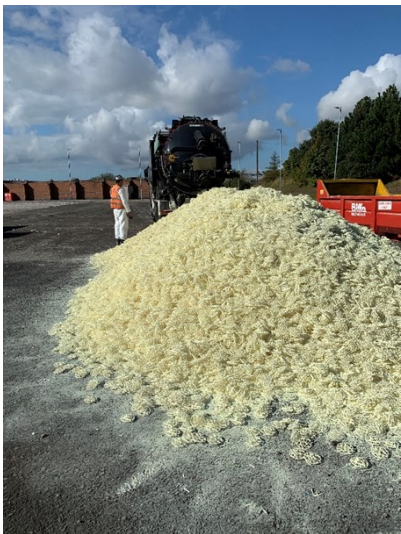
The client's odour control system had built up severe sulphur deposits within the chemical scrubber unit, large diameter ductwork sections and irrigation pipework.

Internal Chemical Scrubber pre-clean out Images:

Clean out scrubber internals of sulphur, recirculation liquor and solids, inline filters, instrument lines and conduct descale.
Conduct inspection of ductwork between WCS outlet and fan inlet- needed to clean out and remove solids.
Replace failed Knit mesh mist eliminator.
Replace all scrubber media with like for like replacement (32m³ volume).
Remove and decontaminate 4-off existing pulsation dampers.
Refit and commission along with existing 4-off discharge pulsation dampers.
Install new water softeners.

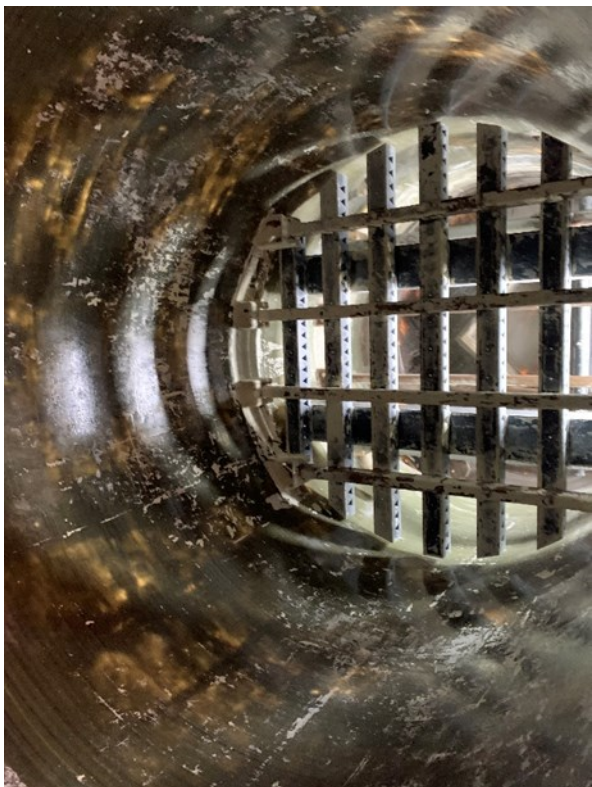
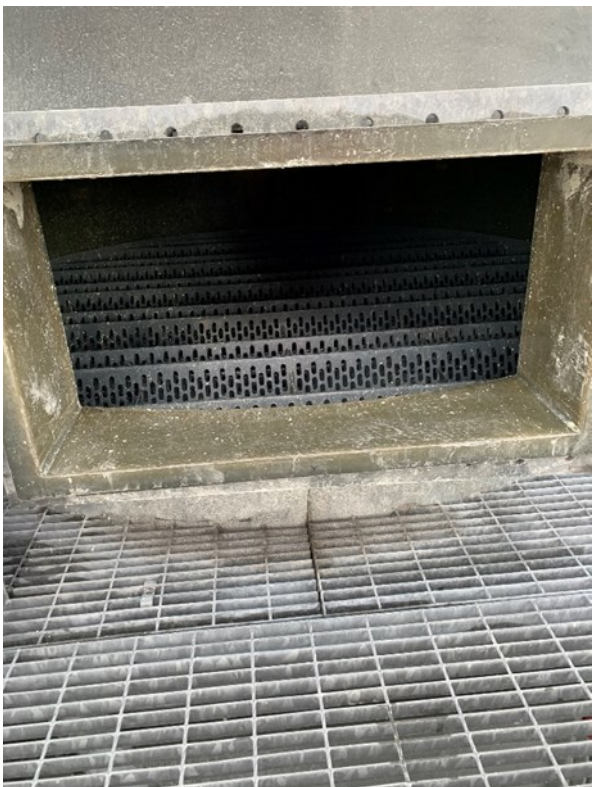
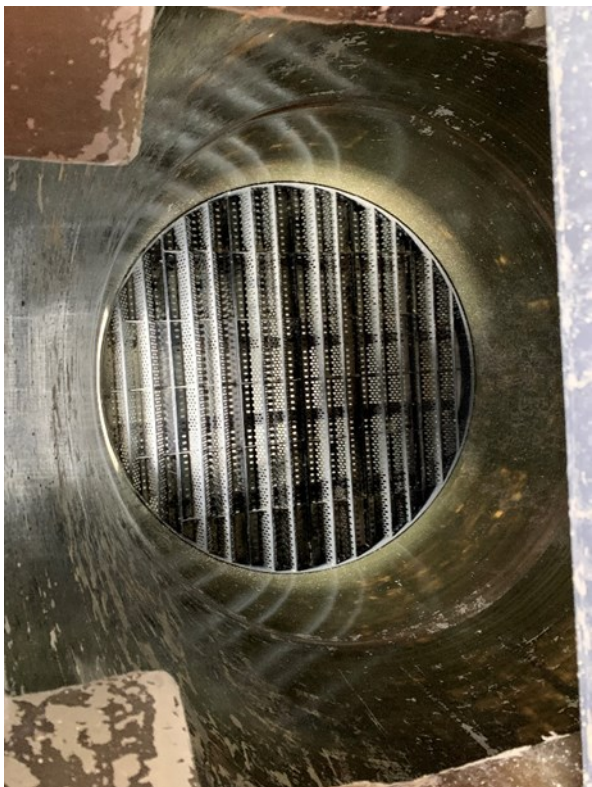
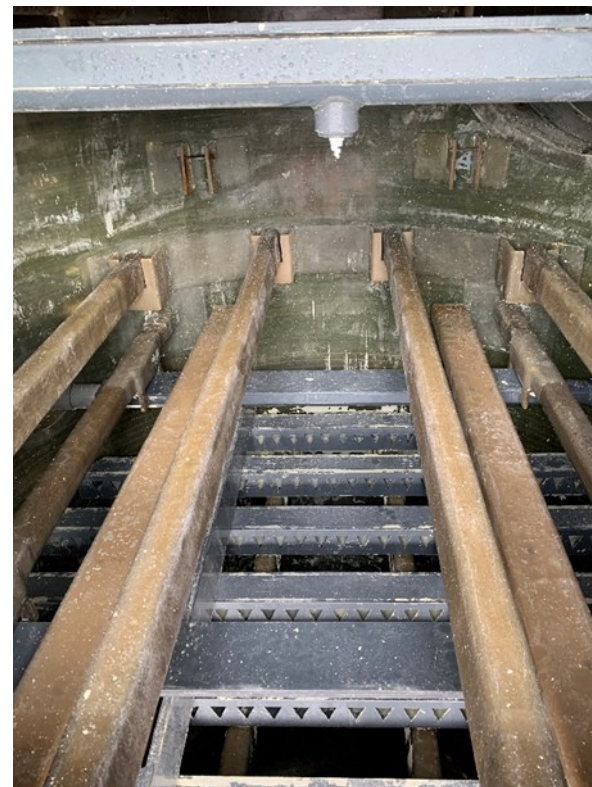
Internal Chemical Scrubber post-clean out Images:

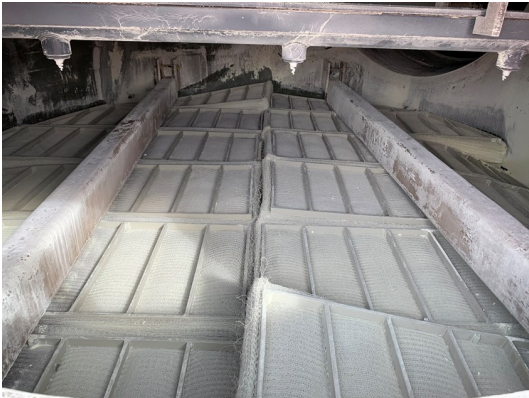
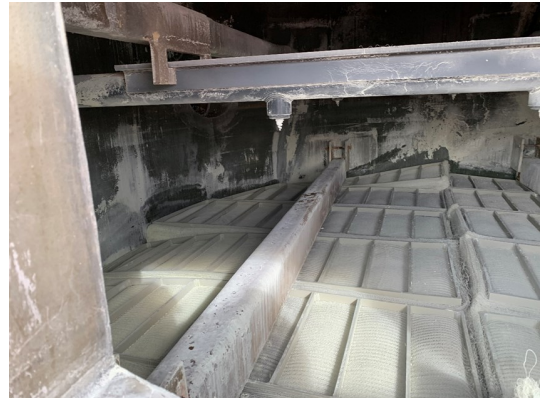
Replace failed knit-mesh eliminator pre-change photos:

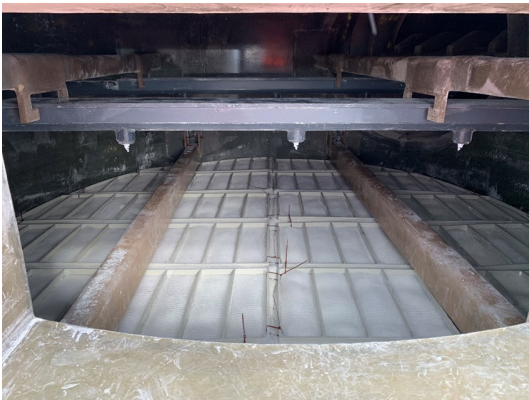
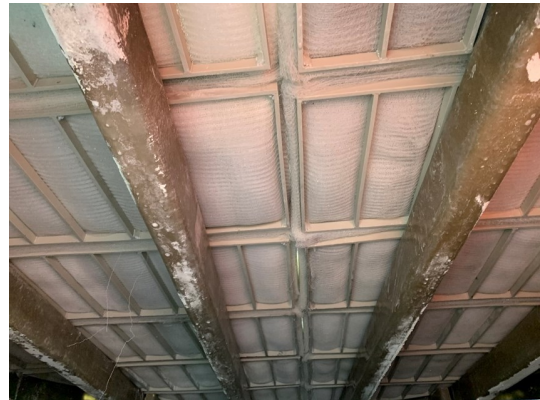
Replace failed knit-mesh eliminator post-change photos:

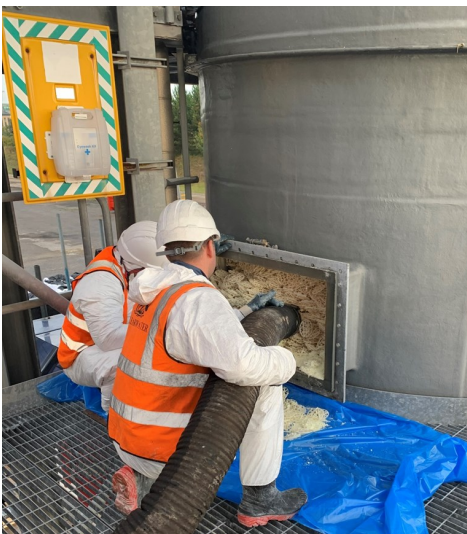
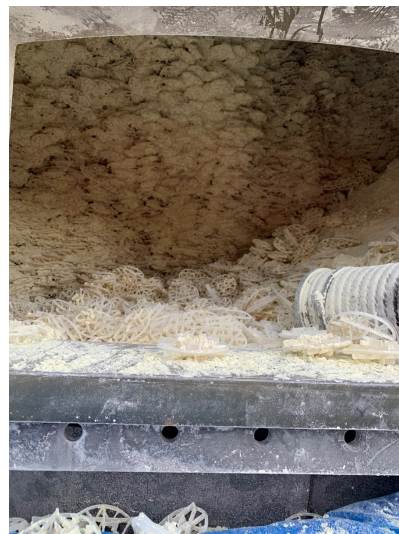
Replace all scrubber media with like for like replacement (32m3 volume)

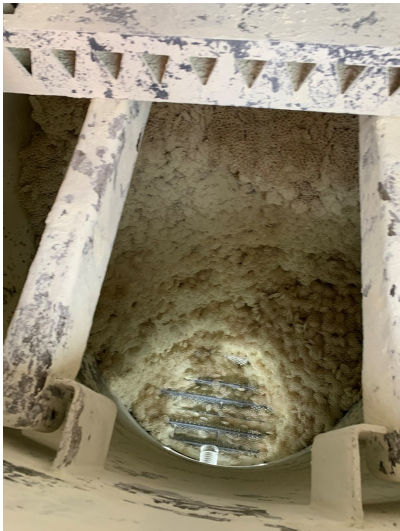
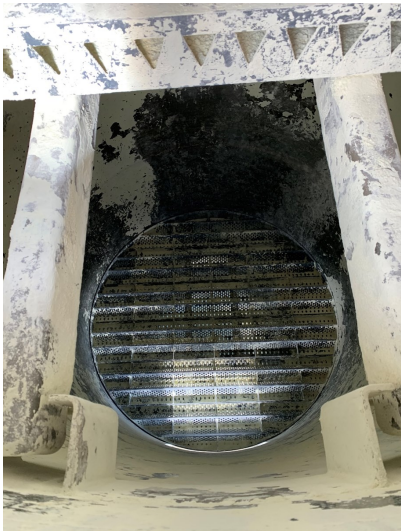
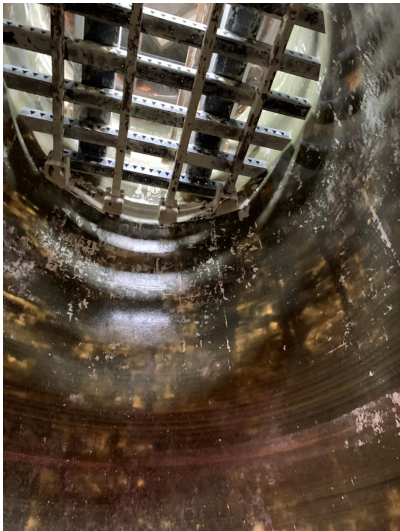
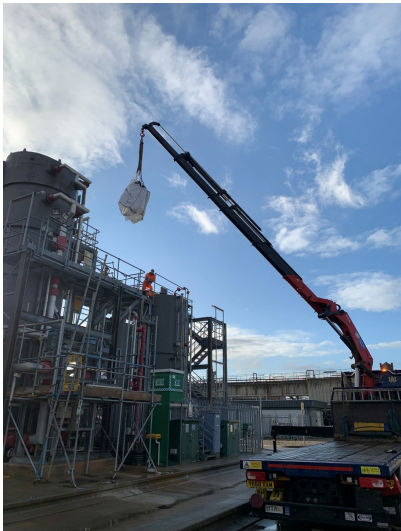
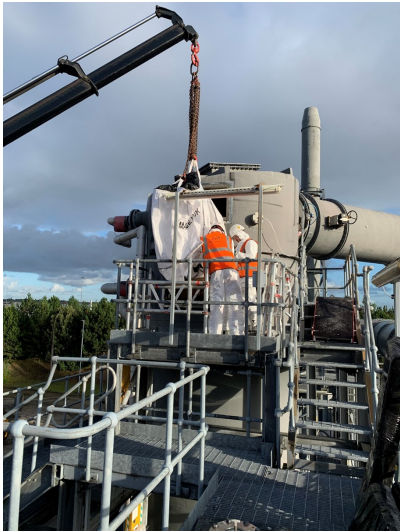
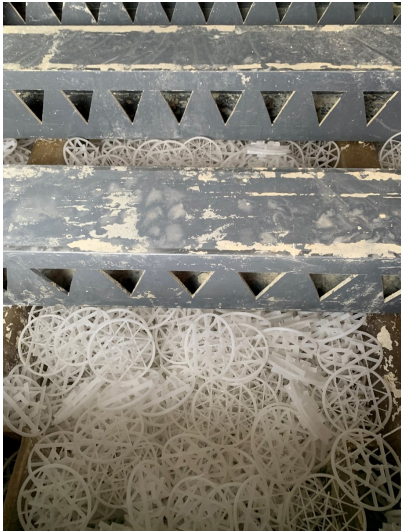
Replace all scrubber media with like for like replacement (32m3 volume)

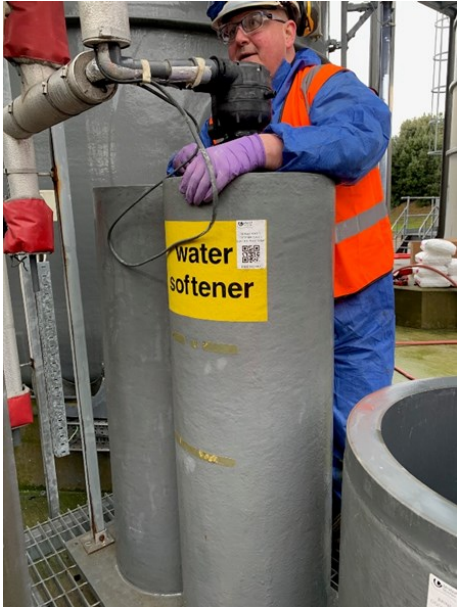
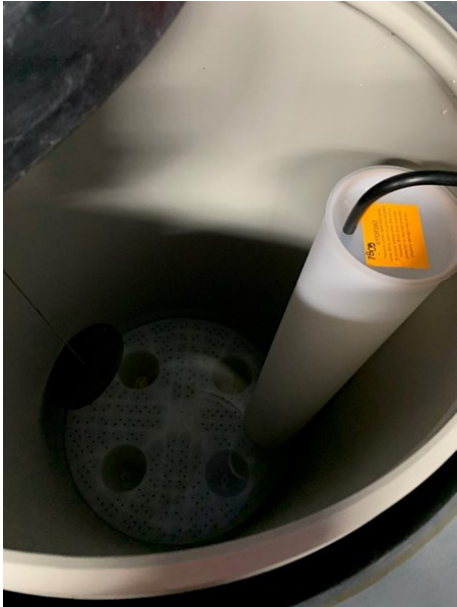
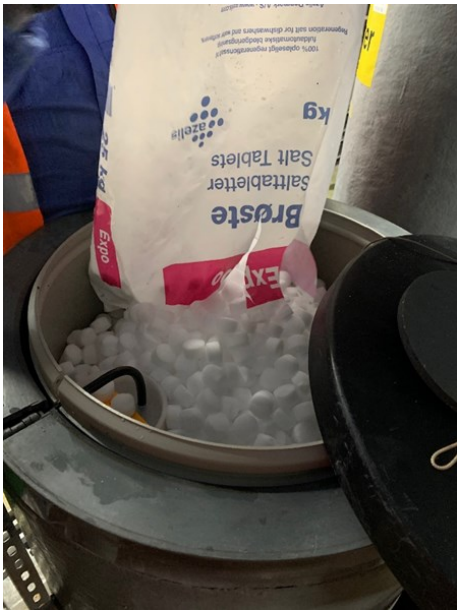
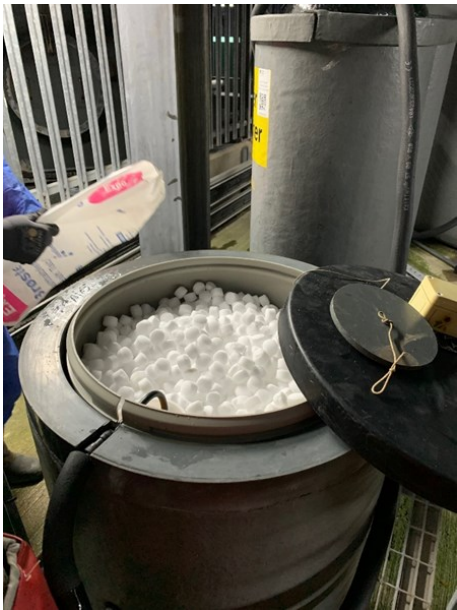
Install new water softeners
