## CASE STUDY

### Banbury STW—Thames Water PFT & SLUDGE AREA ODOUR CONTROL SYSTEMS

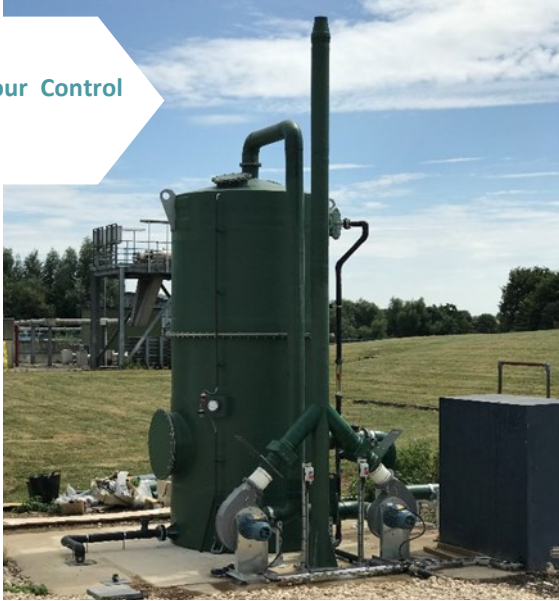
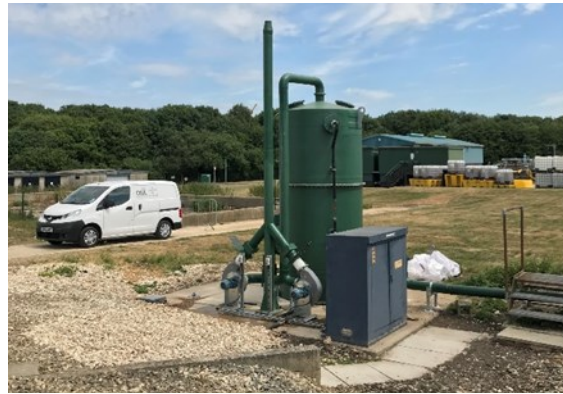
PFT Odour Control System

Upon removal of the first existing asset (PFT Odour Control System) it was evident that the concrete base was not fit for purpose and was not suitable for the new odour control system. The concrete had simply eroded away and was not sustainable for a new installation.

OSIL and Thames Water agreed that a new base slab was required, and Thames Water brought in a specialist ground works contractor to cast a new concrete slab.

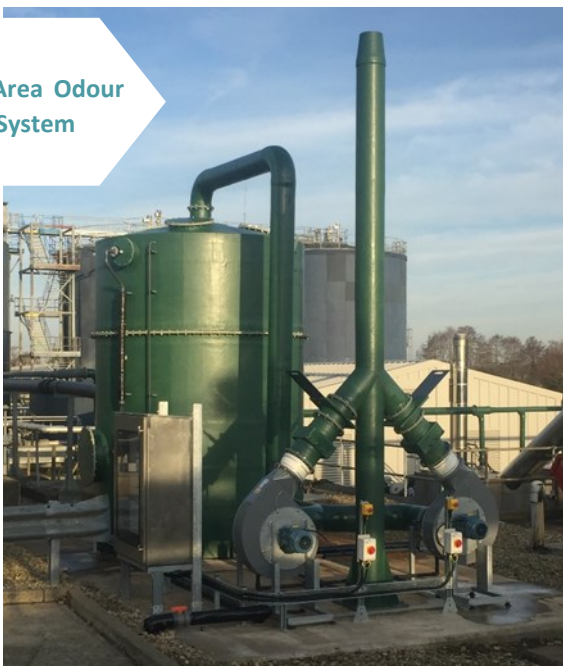
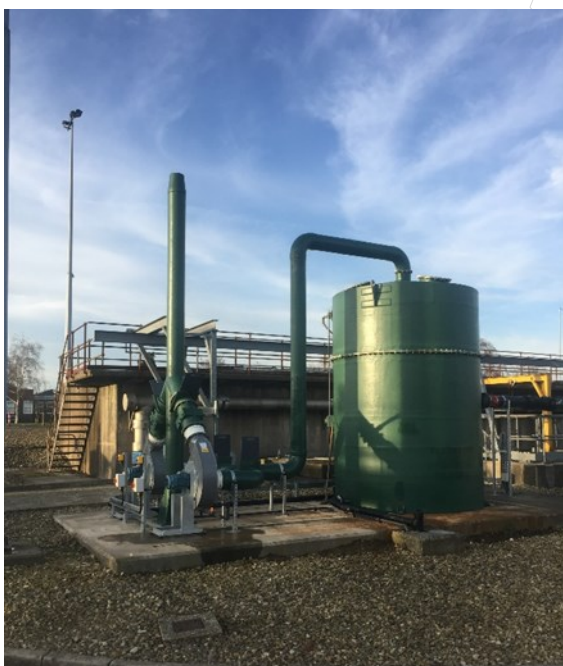
Sludge Area Odour Control System

The previously installed systems had deteriorated beyond repair with years of exposure to UV degradation without the effective materials that allowed for a long-term sustainable product with low maintenance required. The newly installed Biofiltration systems are all DW154 compliant and the LavaRok® media installed within the systems are guaranteed for a minimum of 25 years as long as they are maintained in accordance with the OSIL Operational & Maintenance Instructions.
