## CASE STUDY

### Mill Bay Pumping Station, Plymouth – South West Water ODOUR CONTROL SYSTEM

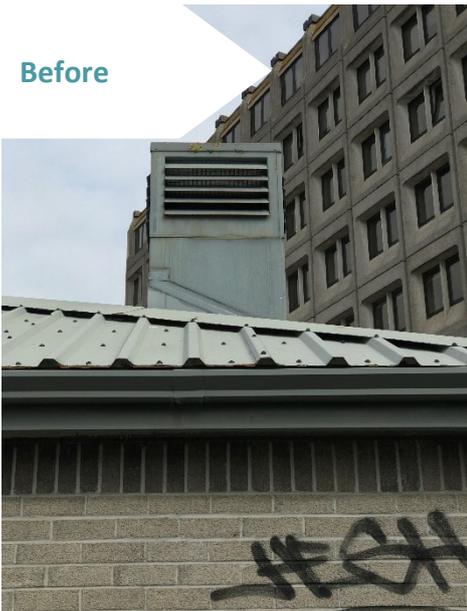
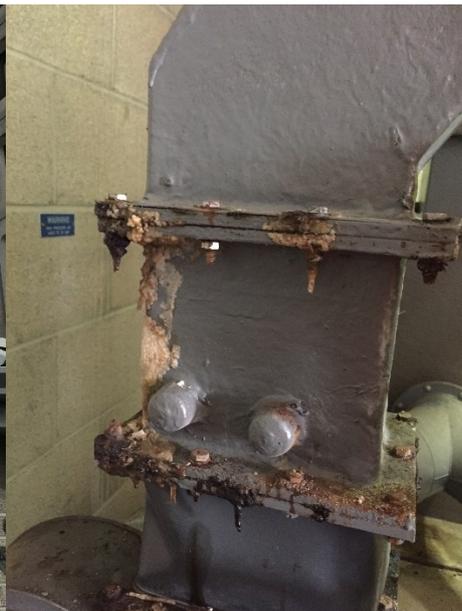
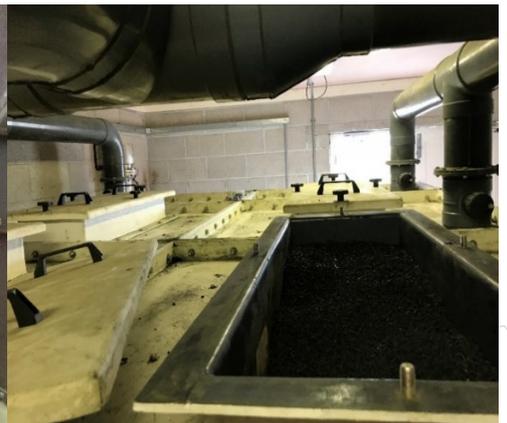
Before

On inspection of the existing Odour Control Unit the media retaining baskets were found to be damaged and due to the age of the unit and the confined nature of the access to the filter this was found to be beyond economical repair. The original design of the existing Odour Control Unit had restricted regular maintenance due to space restrictions around the unit.

OSIL dismantled the existing equipment in sections and disposed of the old equipment in an environmentally friendly manner. OSIL completely redesigned the Odour Control System, offering a much simpler, space saving and much more energy efficient and effective solution to suit the confines of the Pumping Station.

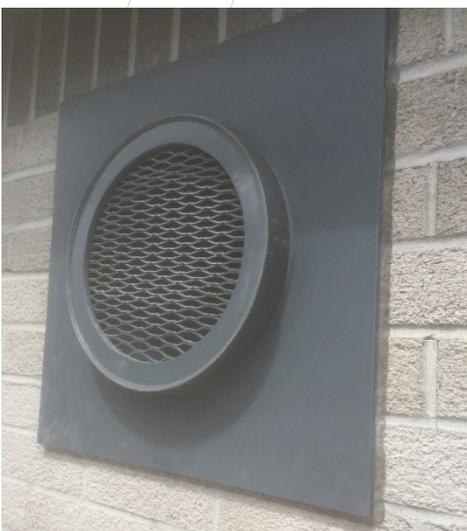
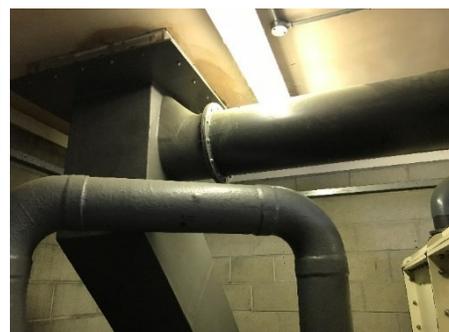
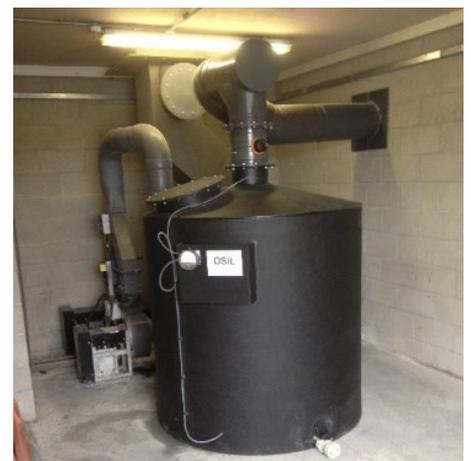
After

New ducting, Control dampers and a brand-new compact designed CuCarb<sup>®</sup> Carbon Filter was installed with new CuCarb<sup>®</sup> media. The new system was then balanced, commissioned and tested to the customers satisfaction.
